SewerLine Check Professionals, LLC

Sewer Line Inspection Report

326 N. Ogden Dr.
Los Angeles, CA
90036

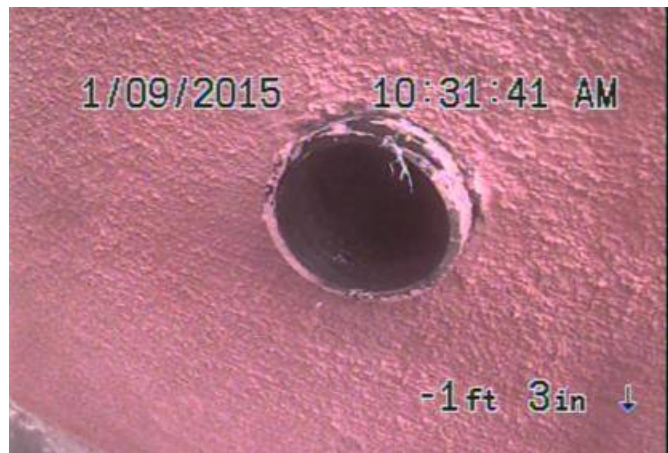
ACCESS LOCATION:

The system was accessed from a 2 inch cleanout located at the front right side of the structure off the driveway.

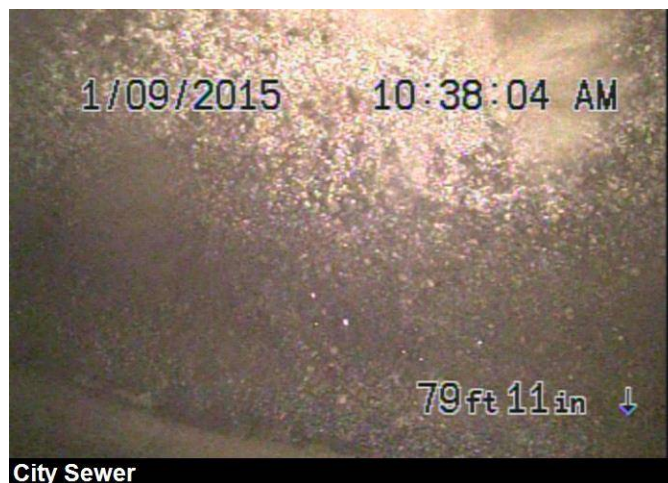
FINDINGS:

The line exits the structure as cast iron piping at the front right corner running at an angle towards the

driveway, at the sidewalk the line changes over to concrete piping that runs out under the street to the city connection.

Needs Attention: Cast iron pipe was typically expected to have an average service life of approximately 70 to 80 years. While this pipe is showing signs of aging with moderate to heavy rust and scale buildup, It is still functioning but it will need to be upgraded/rehabilitated in the future as it continues to deteriorate. When a cast iron pipe main sewer line gets to this condition, it is our recommendation that the pipe be considered for upgrades but it is reasonable to suggest that one could monitor the pipe with regular video examinations annually. This service can help to better project a future replacement date and can help to catch any potential future failures at an early stage.

The lateral portion of this system(that portion of the system that was provided to the property when it was developed and connects the properties main sewer line to the city maintained sewer) was found to be made of concrete pipe. While the conditions found in this portion of the system were found to be normal, there are situations that may require this concrete pipe to be rehabilitated with an approved lining system. The City of Los Angeles has adopted a policy as of January 2007 that basically states that any property developed prior to 1965 would require a video examination of the lateral pipe to the property in the event of a construction related building permit being applied for. If that pipe is found to be made of concrete, it shall be rehabilitated with an approved lining system at the property owners expense. More information can be found through the local Department of Building and Safety regarding this policy. This is mentioned because additional costs could be expected to rehabilitate this sewer line in the event of future building additions or alterations.

The system needs a main four inch cleanout to properly clean and maintain the system. An area was flagged out where the cleanout should be installed.

A standard 4 inch cleanout should cost about \$600-\$800.

Should one choose to be proactive with lining the concrete they may be looking in the ranges of \$6,000 - \$7,000.
