# **SewerLine Check Professionals, LLC**

## **Sewer Line Inspection Report**

6413 Willoughby Ave. Hollywood, CA

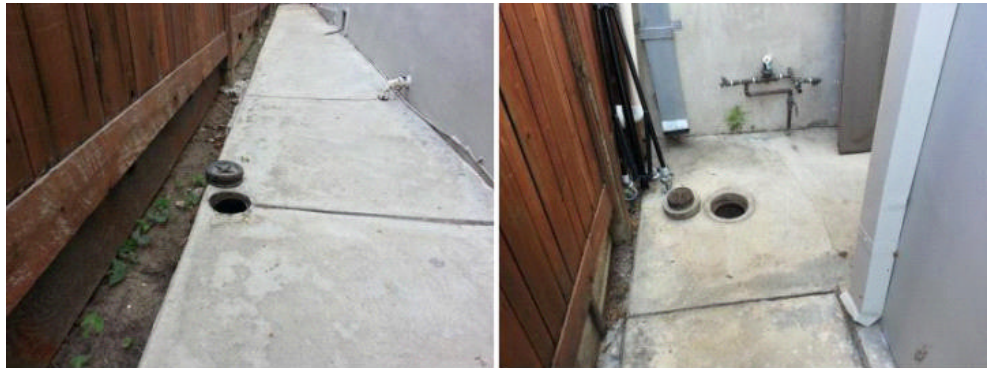
**ACCESS LOCATION:** The sewer line access for the front house is found along the left side of the house. The duplex sewer line can be accessed using the cleanout found at the left front of this rear building.

The second cleanout should be used for the recommended maintenance in this report.

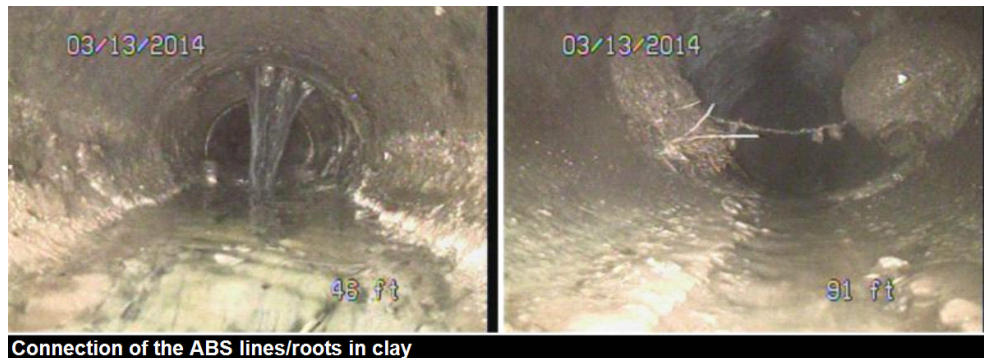
Some sections of this plastic system have typical low spots that is causing some sewer water to pool in the pipe. This bowing of the pipe is common in a plastic system and generally does not require repair as water will find its own level in the pipe and then drain off. There is some excessive film and slight debris build up these sections of the plastic system that should be cleared to prevent any slow drainage that may occur over time.

There are areas of root intrusion within this clay portion of main sewer line that will need to be cleared by a sewer cleaning agency in the future. Roots intruding into a clay system are common and can normally be maintained with regular sewer line cleanings. Its when roots are left unmaintained for an extended period of time that they can cause blockages and even damage in a clay system. No damage was observed in these areas nor are the roots in the line presently effecting the drainability of the system and it is advised to have them cleared within the next 3 to 6 months and then maintained on an 8 to 10 month schedule.

While the conventional snaking method is suitable for the regular root maintenance that the clay section will require over time, this method may not be able to clear the sludge like environment occurring in the plastic sections. For this sewer cleaning hydro jetting is recommended. Hydro jetting is a highly effective type of sewer cleaning that incorporates high pressure water which forces debris away from the inner walls of the pipe and flushes them down the system.

Hydro jetting should be performed to clear the film and debris building up in the plastic section. This will clear the initial root growth in the clay portion as well.
