Inspection Report

Property Address:
3426 N. Ogden Dr.
Los Angeles CA 90036

Infrared Inspection

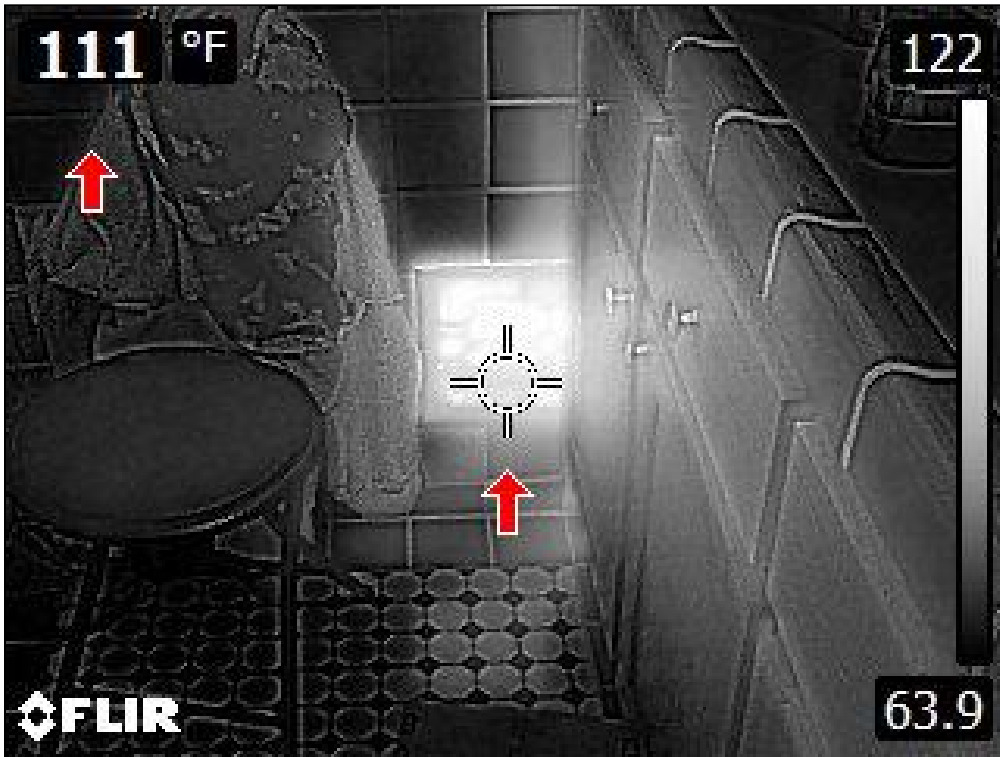
2.7 Moisture was noted on exterior walls and the moisture content reads between 30-48%, Owner to have a licensed contractor to inspect & make corrections.

In pictures # 2-5 are showing the temperature of heat coming from registers

NOTE: our meter only reads to 50 so therefore for actual read it needs to be doubled.

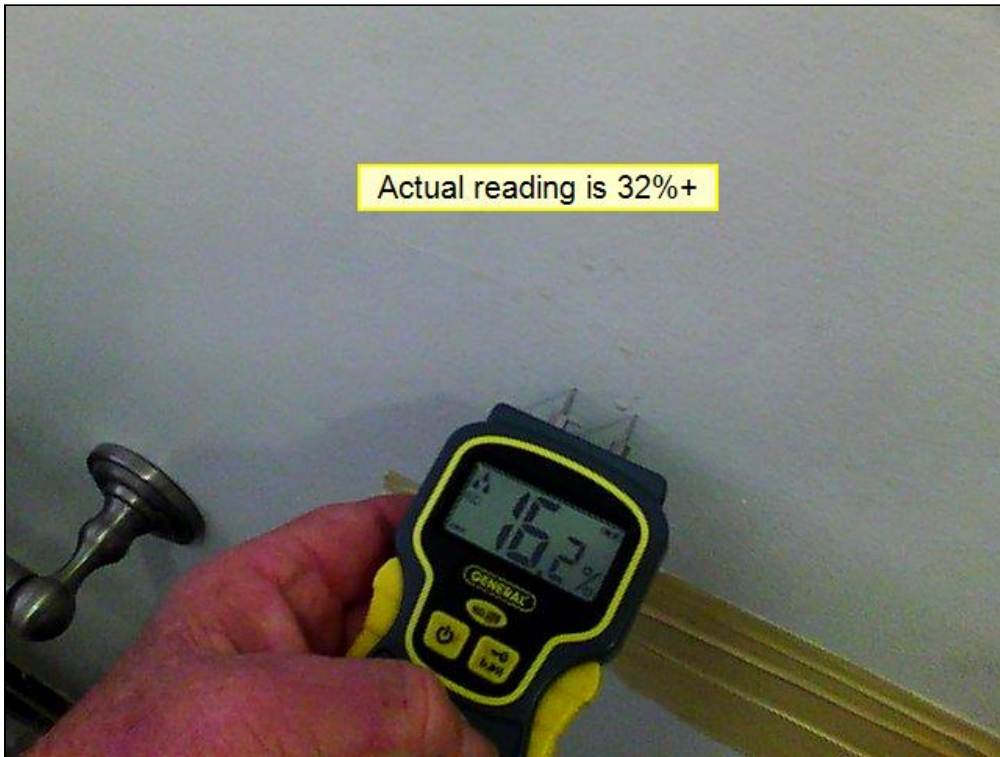
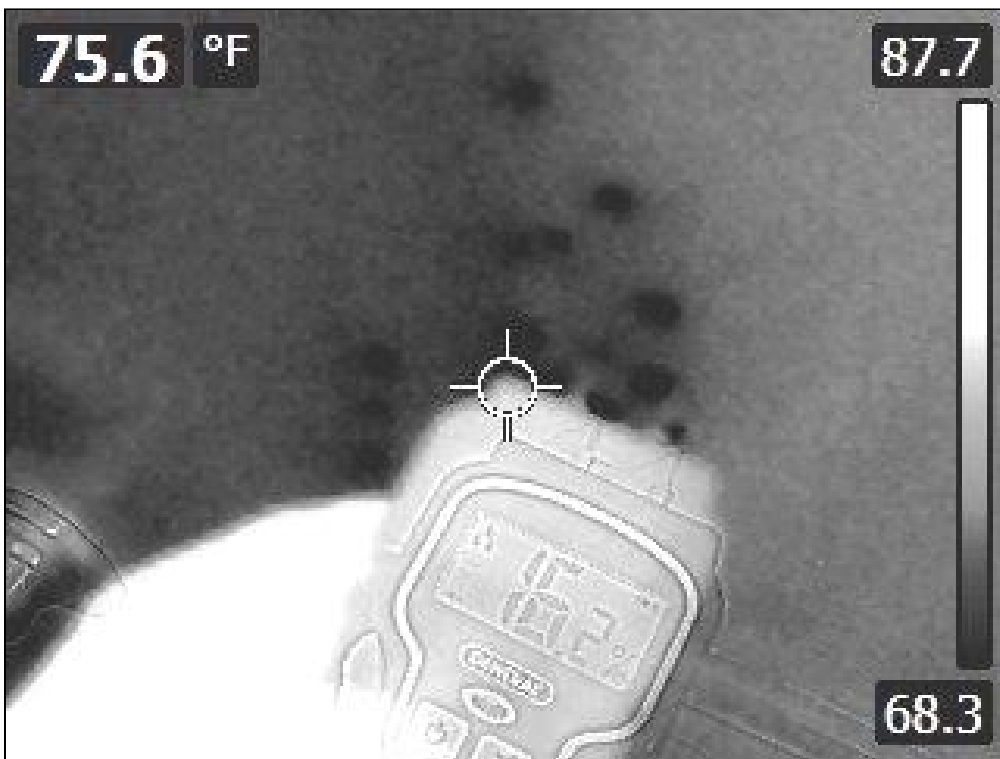
4.7 In front unit bathroom there was signs of moisture as indicated on the pictures, Owner to have a licensed contractor inspect & make repairs.

In the master bedroom wall their are water satins & bubbling of paint, No signs of moisture was noted @ time of inspection, however its believed that these problems in a few rooms is build up of condensation from a/c unit (as this apparently happens during prolong use of a/c units).

We recommend that the a/c unit be run for a minimum of 30 minutes before another inspection up to 1 hour to make a final determination of problem.

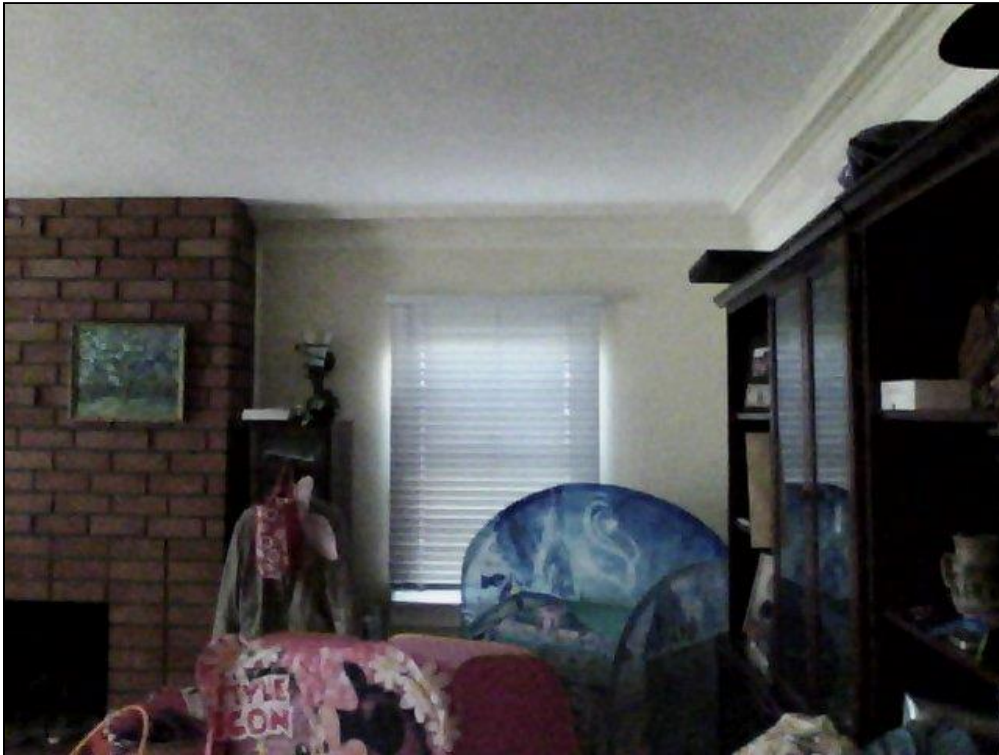
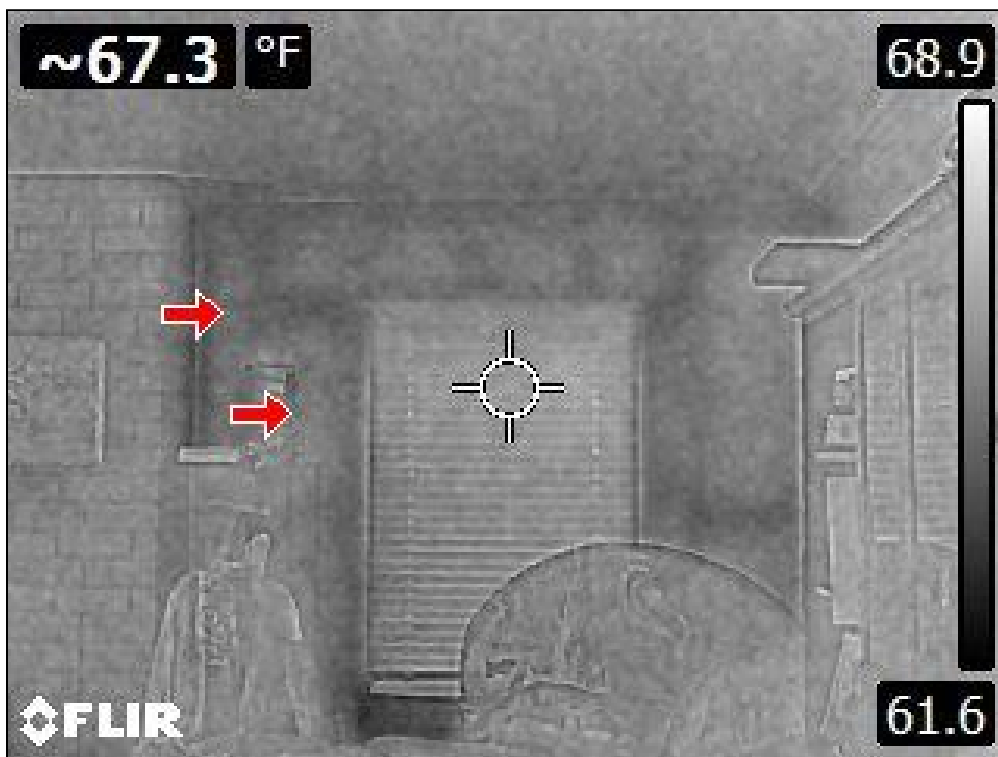
5.1 The front unit near fireplace has an improper framing of window- it appears to have had a smaller window installed, Owner to have a licensed contractor inspect & make necessary repairs.

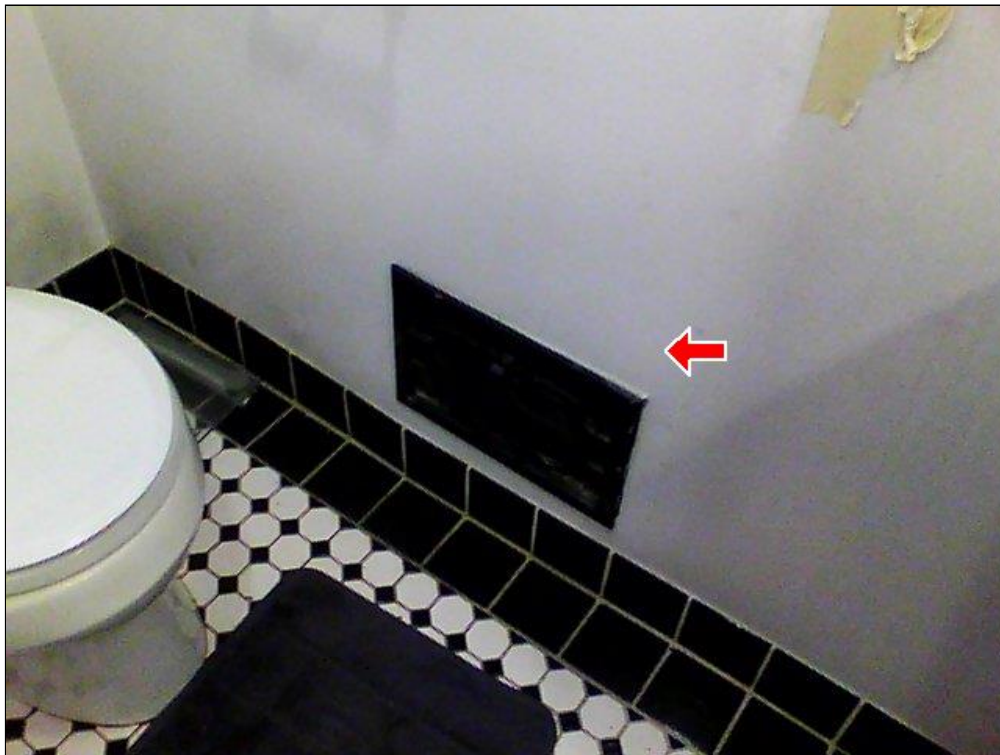
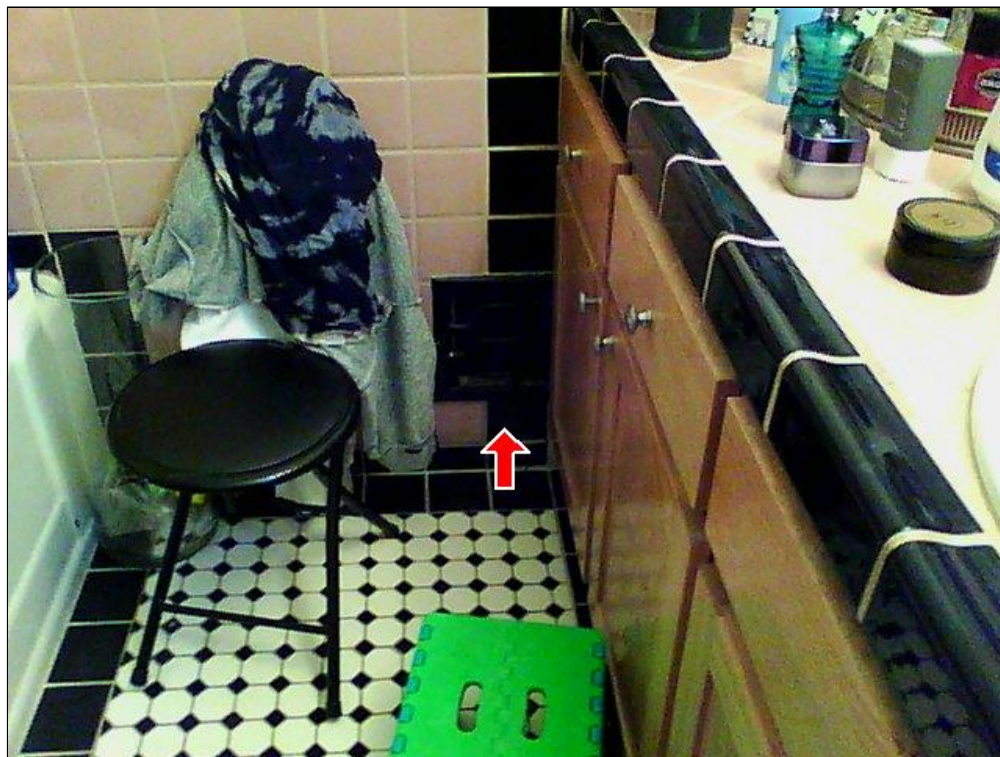
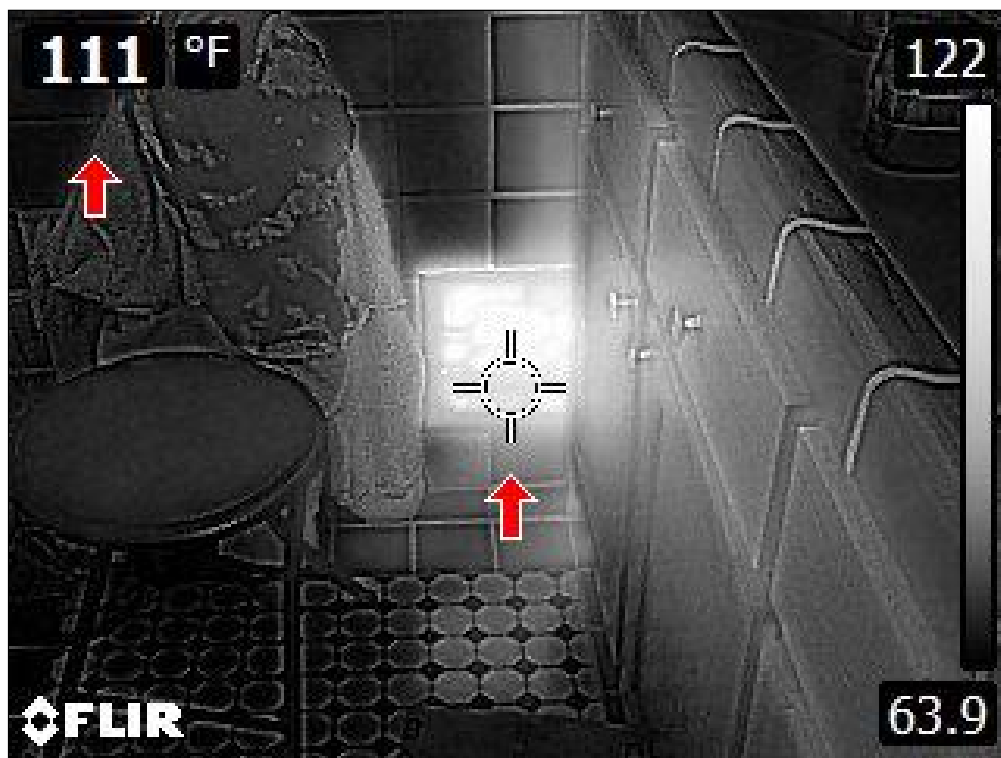
Moisture was noted on exterior walls and the moisture content reads between 30-48%, Owner to have a licensed contractor to inspect & make corrections.

In pictures # 2-5 are showing the temperature of heat coming from registers

NOTE: our meter only reads to 50 so therefore for actual read it needs to be doubled.

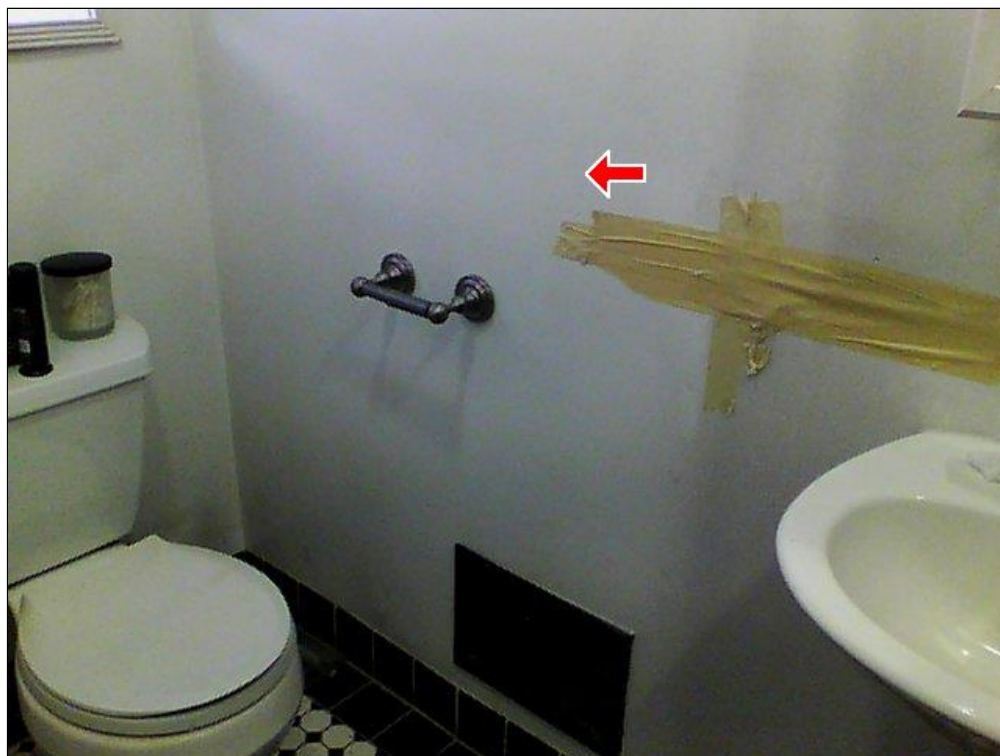
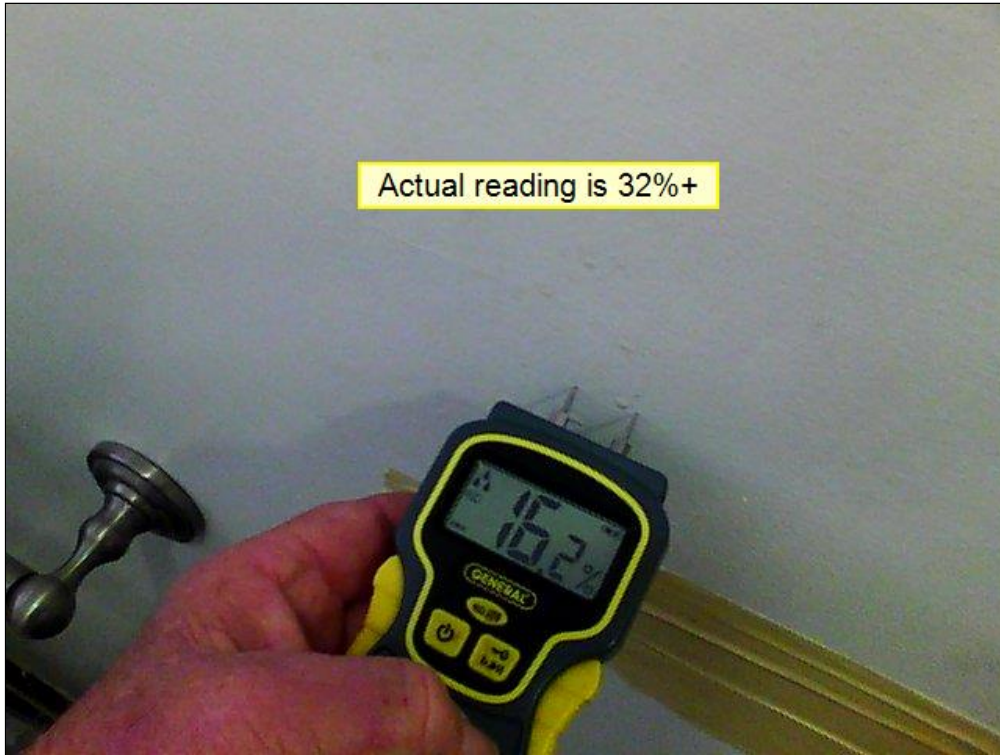
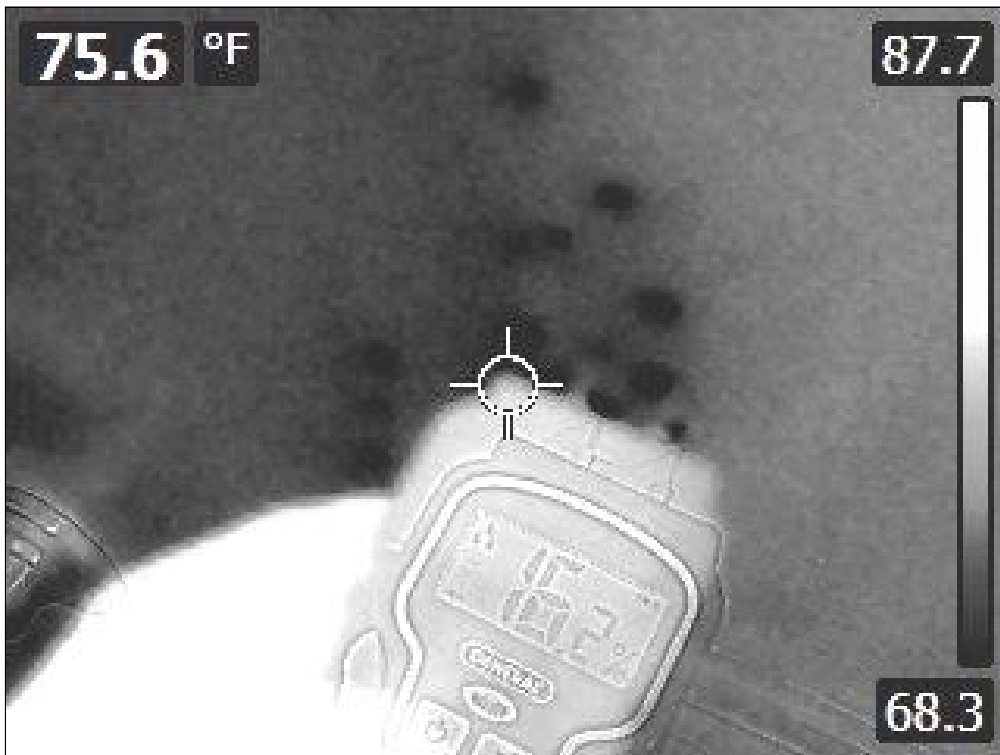
In front unit bathroom there was signs of moisture as indicated on the pictures, Owner to have a licensed contractor inspect & make repairs.

In the master bedroom wall their are water satins & bubbling of paint, No signs of moisture was noted @ time of inspection, however its believed that these problems in a few rooms is build up of condensation from a/c unit (as this apparently happens during prolong use of a/c units).

We recommend that the a/c unit be run for a minimum of 30 minutes before another inspection up to 1 hour to make a final determination of problem.

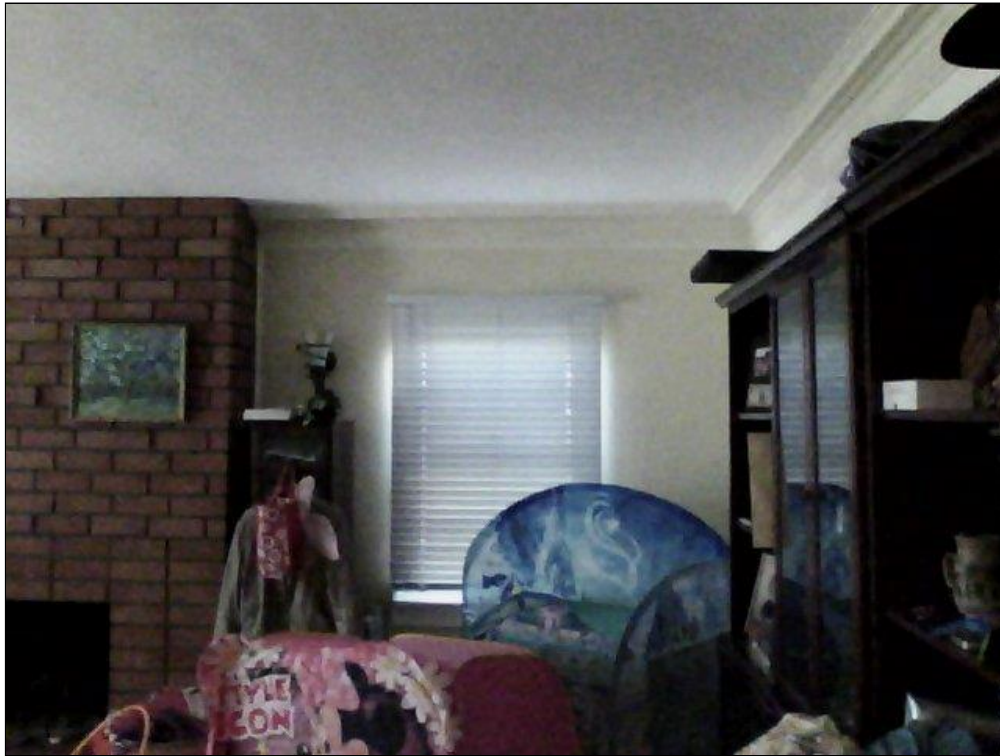
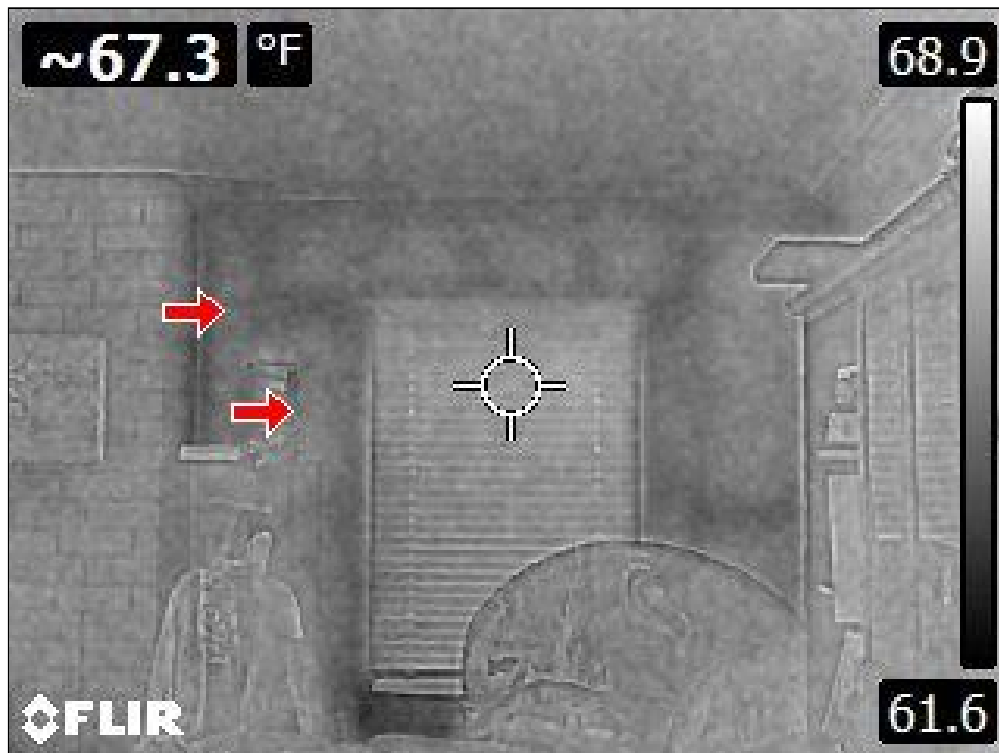
The front unit near fireplace has an improper framing of window- it appears to have had a smaller window installed, Owner to have a licensed contractor inspect & make necessary repairs.
