Inspection Report

Property Address:
3426 N. Ogden Dr.
Los Angeles CA 90036

Infrared Inspection

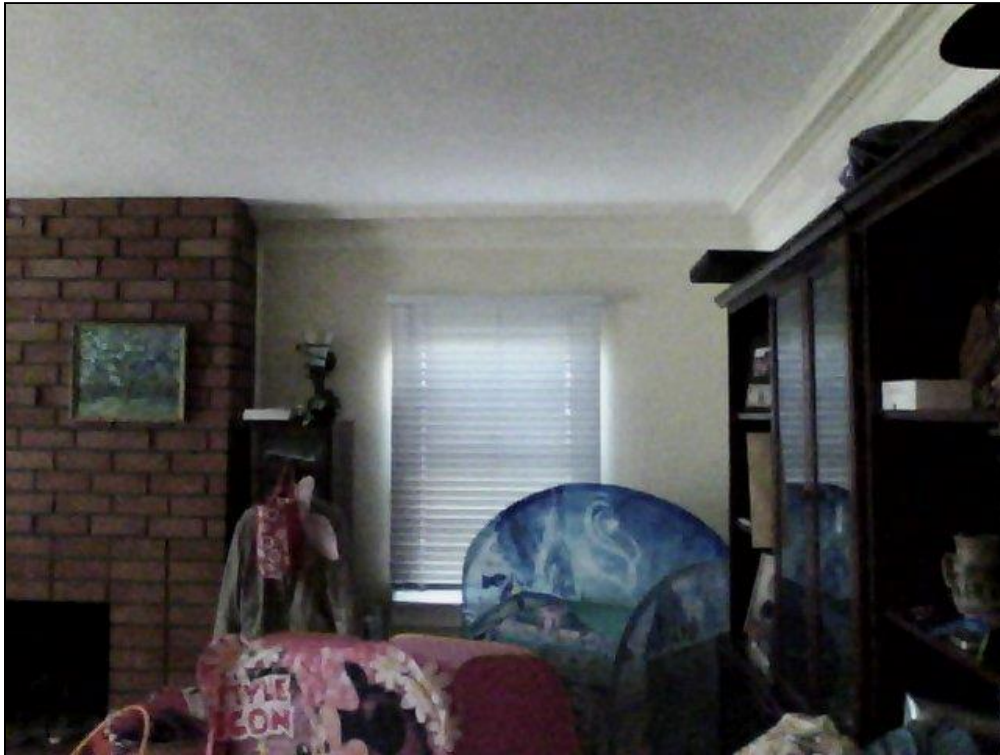
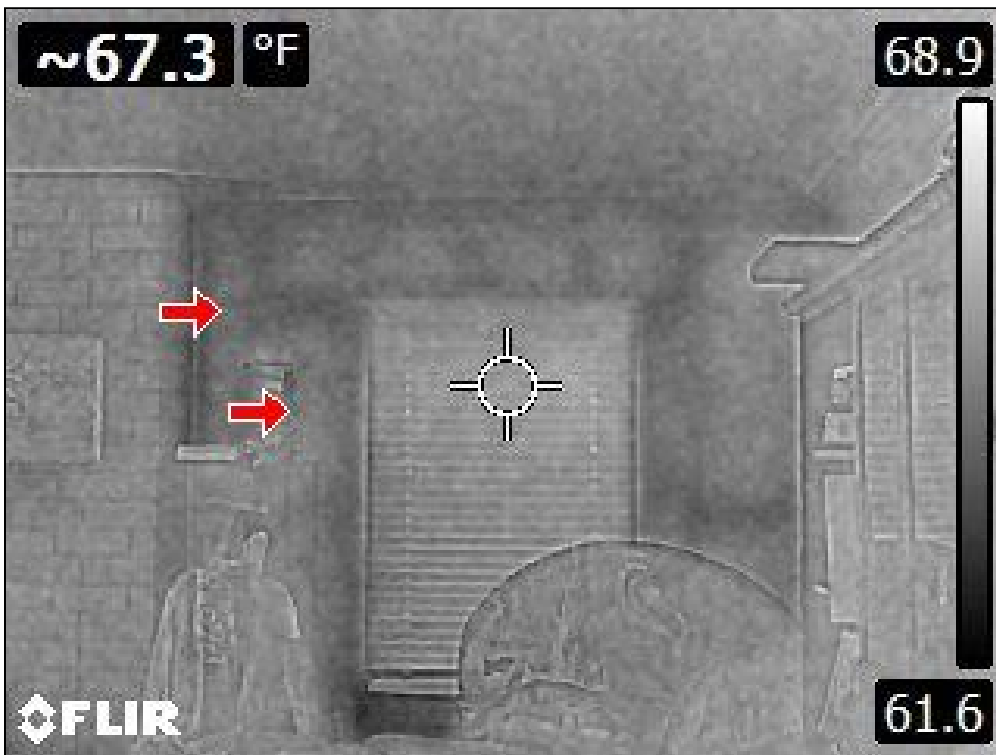
5.1 Item 1(Picture)

5.1 The front unit near fireplace has an improper framing of window- it appears to have had a smaller window installed, Owner to have a licensed contractor inspect & make necessary repairs.
