Inspection Report

Property Address:
326 N. Ogden Dr.
Los Angeles CA 90036

Infrared Inspection

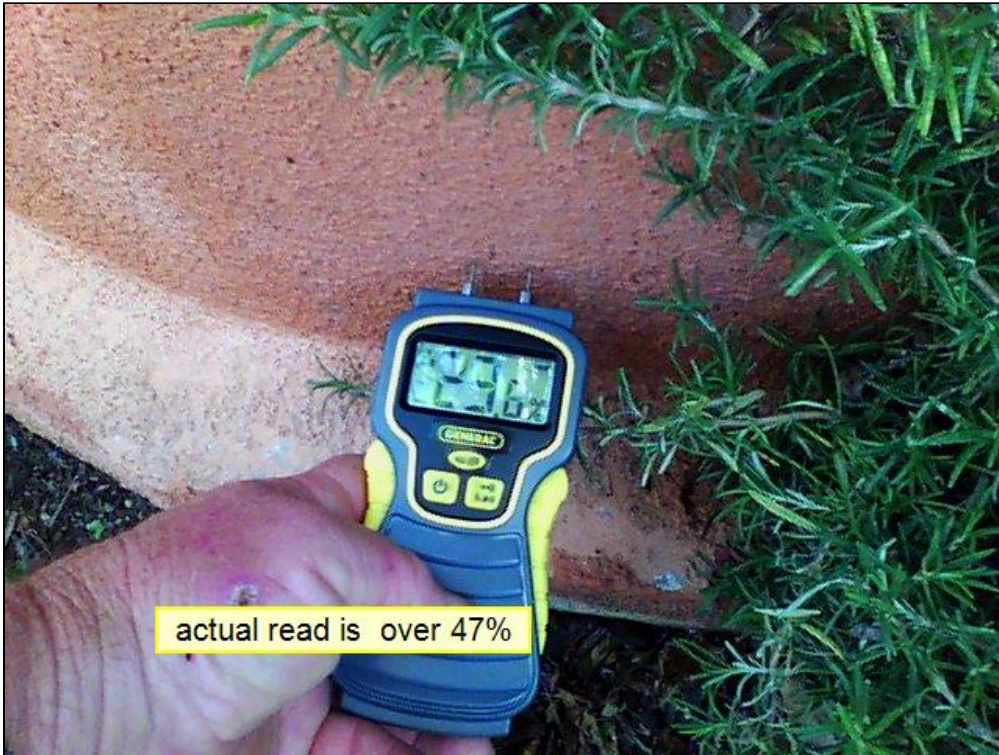
2.7 Item 1(Picture)

2.7 Moisture was noted on exterior walls and the moisture content reads between 30-48%, Owner to have a licensed contractor to inspect & make corrections.

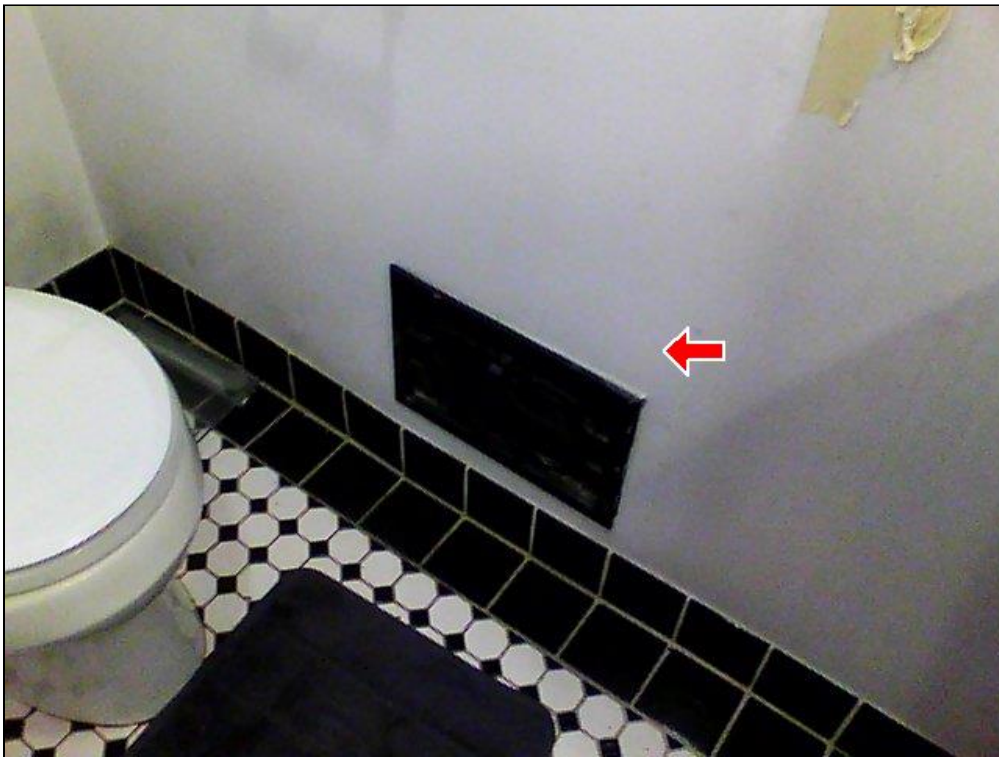
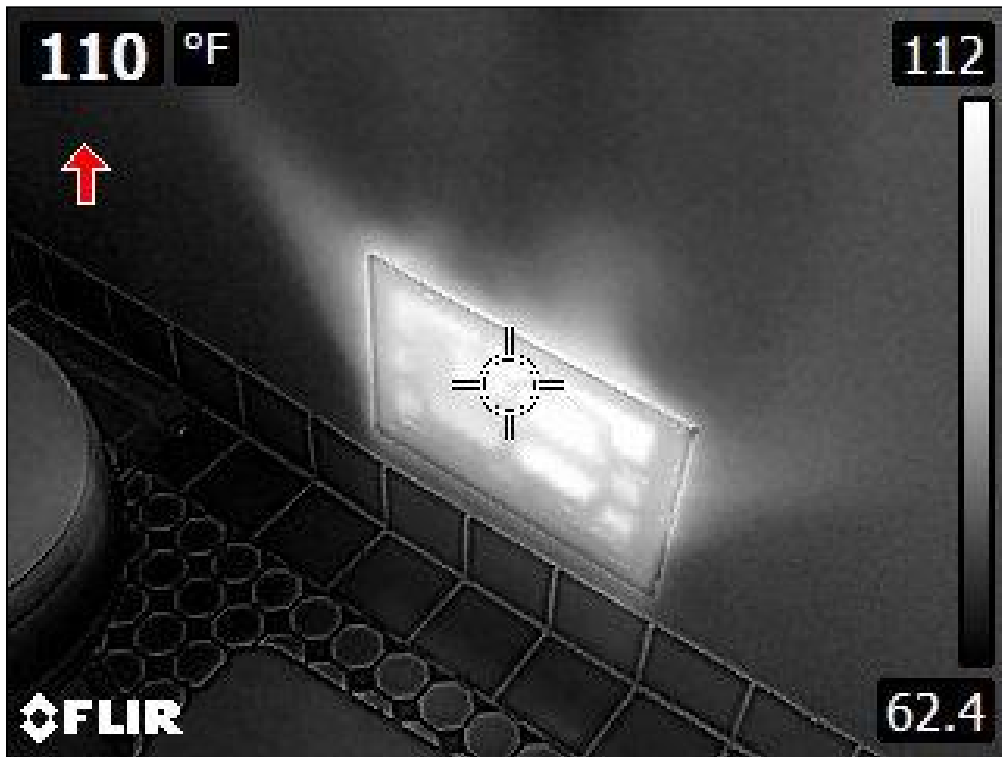
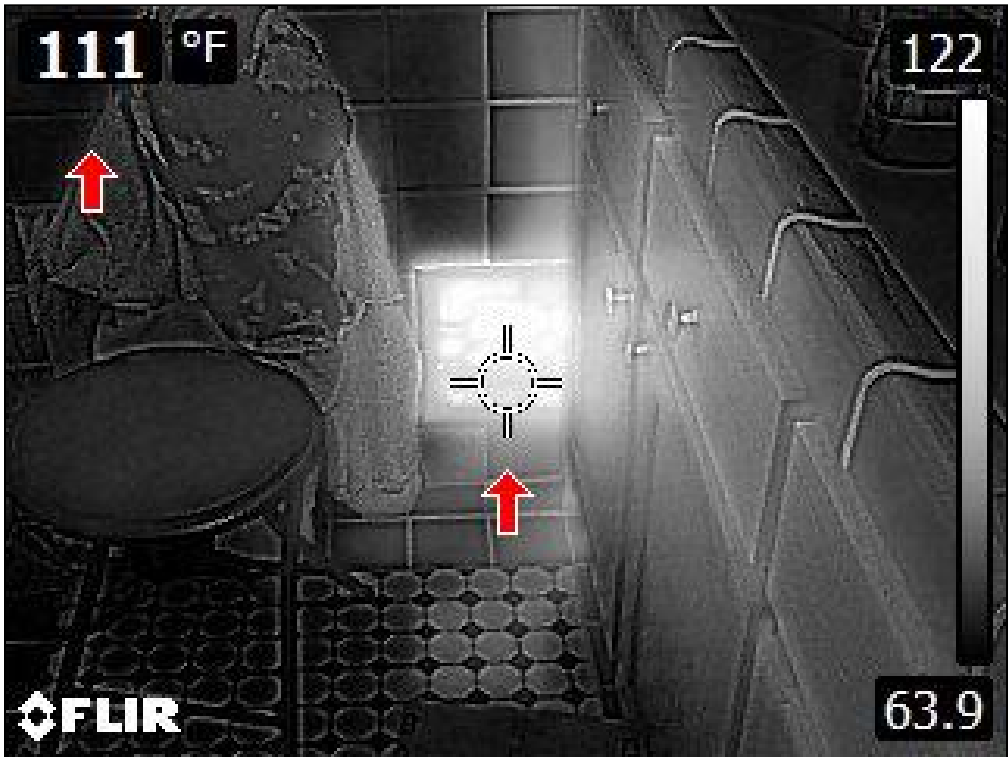
2.7 Item 2(Picture)

In pictures # 2-5 are showing the temperature of heat coming from registers

NOTE: our meter only reads to 50 so therefore for actual read it needs to be doubled.

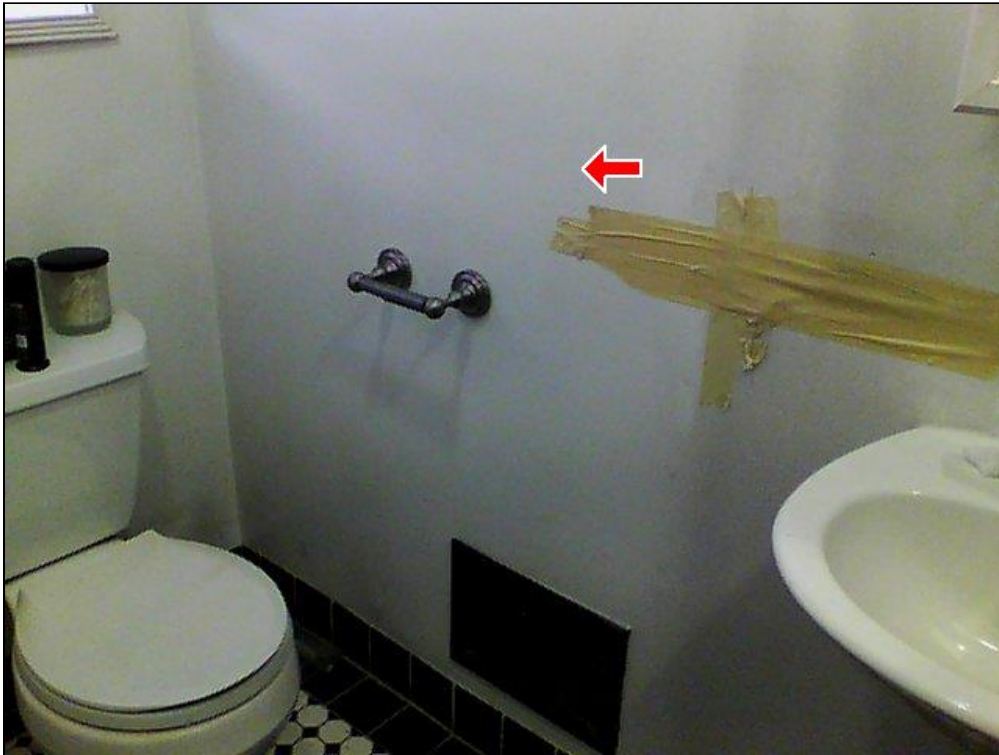
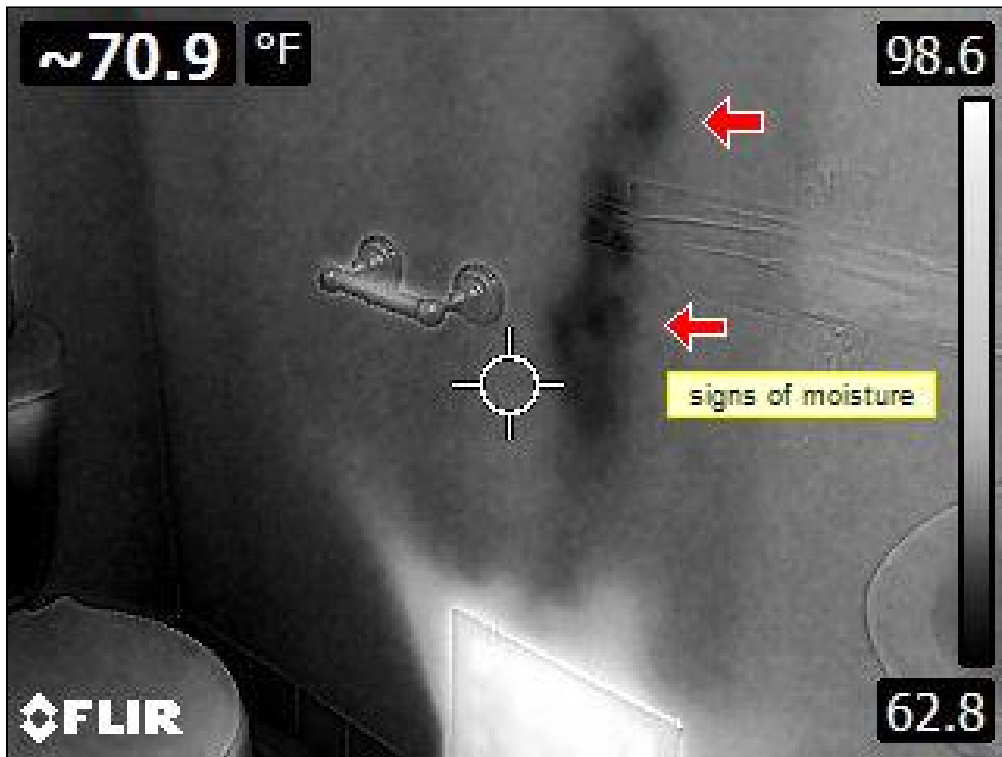
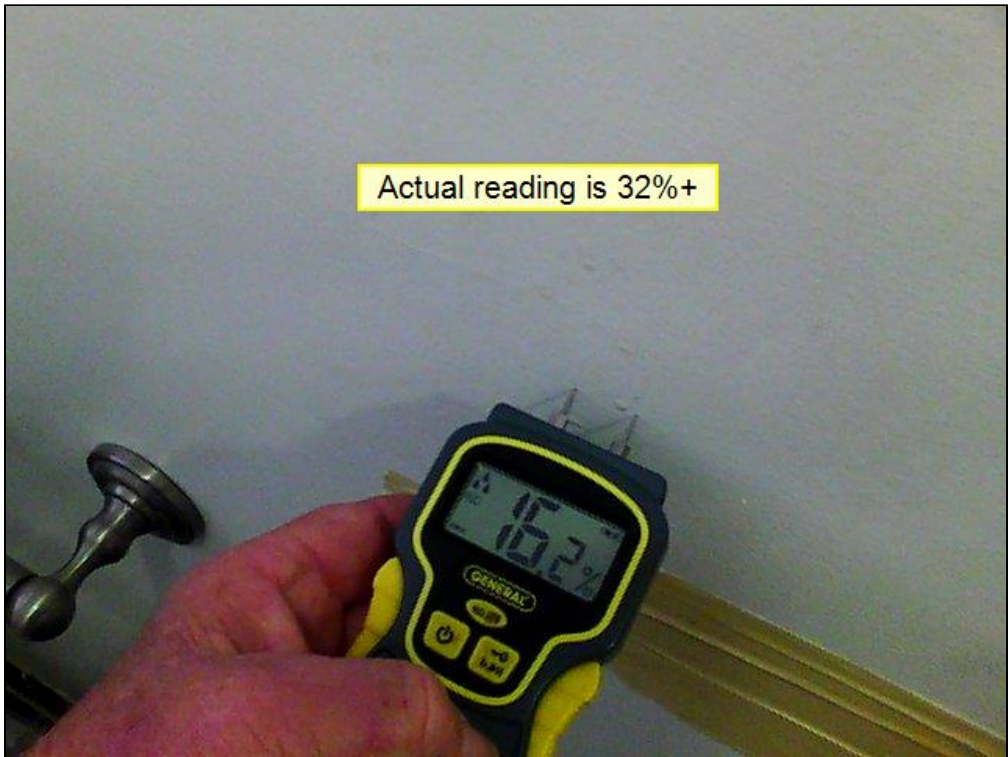
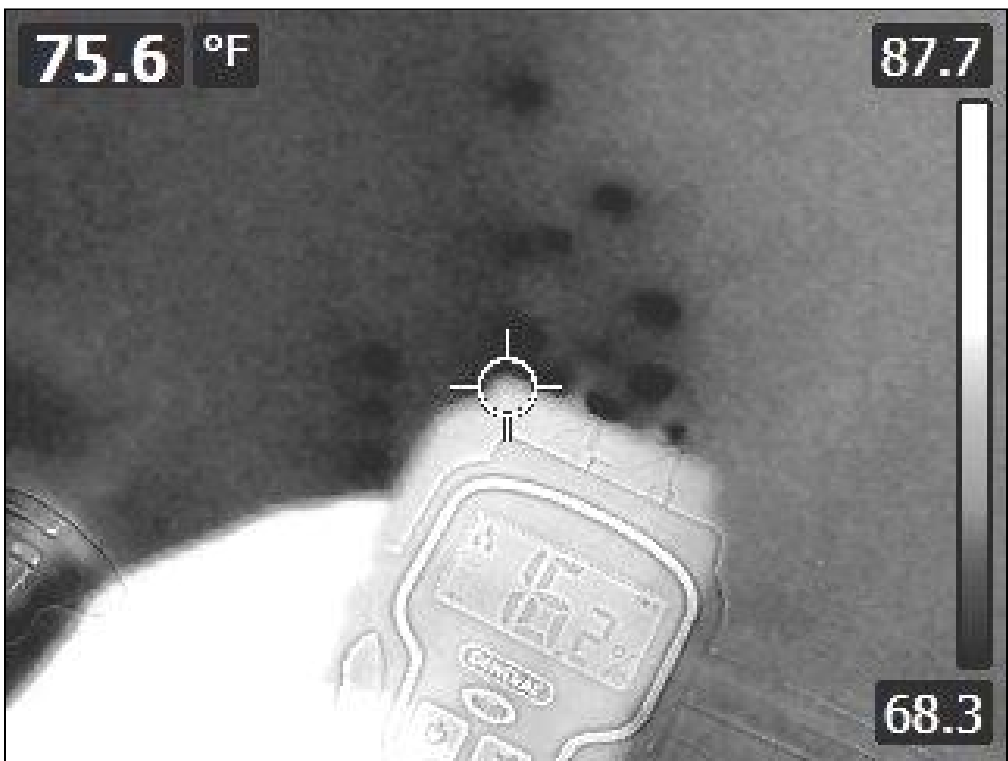
4.7 Item 1(Picture)

4.7 In front unit bathroom there was signs of moisture as indicated on the pictures, Owner to have a licensed contractor inspect & make repairs.

In the master bedroom wall their are water satins & bubbling of paint, No signs of moisture was noted @ time of inspection, however its believed that these problems in a few rooms is build up of condensation from a/c unit (as this apparently happens during prolong use of a/c units).

We recommend that the a/c unit be run for a minimum of 30 minutes before another inspection up to 1 hour to make a final determination of problem.

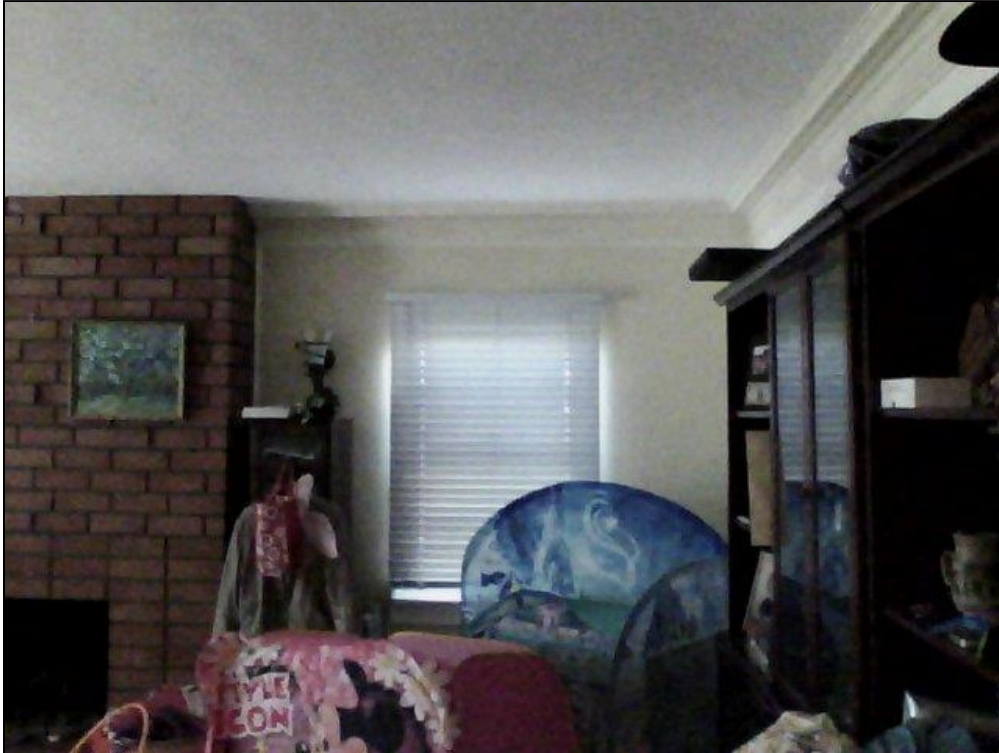
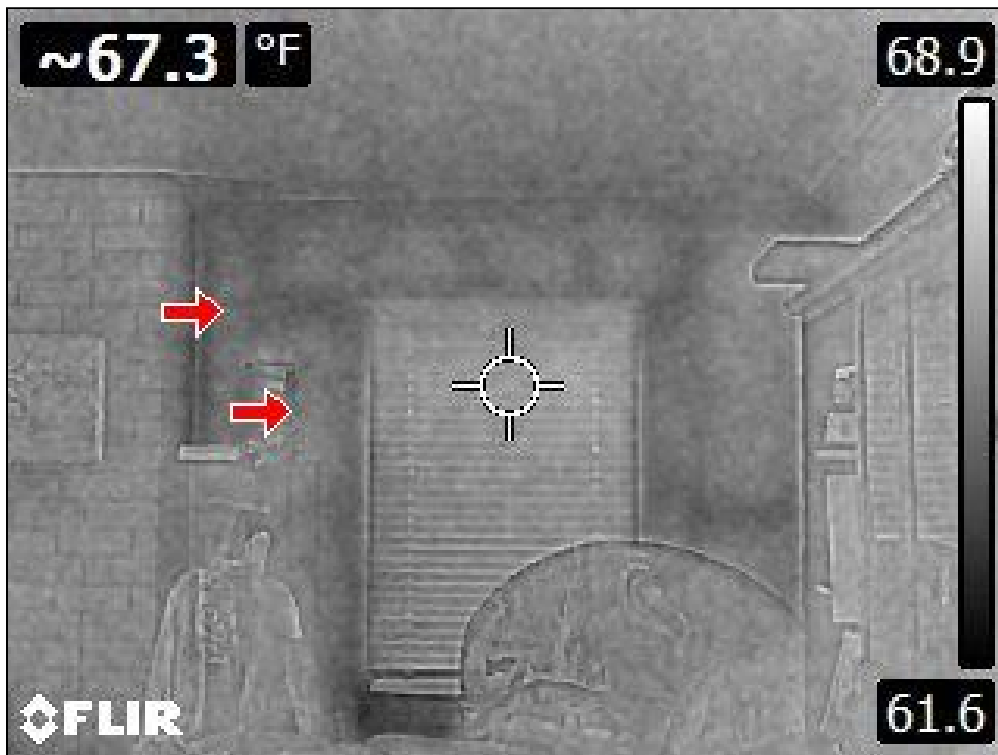
5.1 Item 1(Picture)

5.1 The front unit near fireplace has an improper framing of window- it appears to have had a smaller window installed, Owner to have a licensed contractor inspect & make necessary repairs.
