# Chimney Inspection Report

## Isabelle & Daniel March

326 N. Ogden Dr. Los Angeles, CA 90036

January 9, 2015.

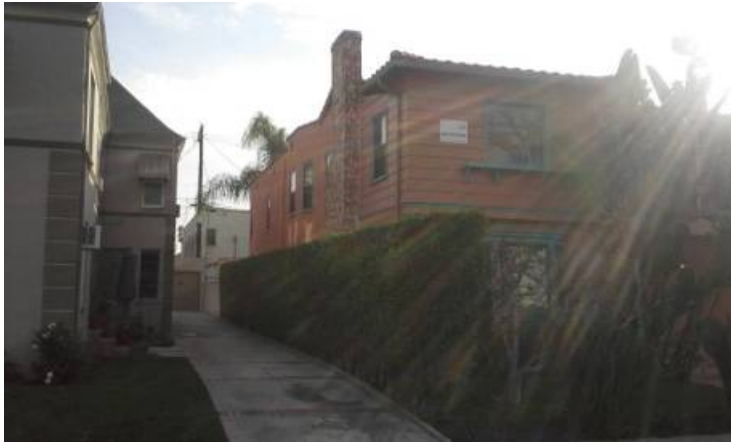
### CHIMNEY TYPE:

The chimney is made of masonry. This is a reinforced masonry structure (this is when the chimney has metal reinforcements built into the system, otherwise known as rebar).

The lower unit fireplace system is a two story fireplace system and this is the only Fireplace that I inspected.

The remaining upper floor fireplace and its flue are not part of my inspection. This fireplace and flue should be inspected and repaired before use.

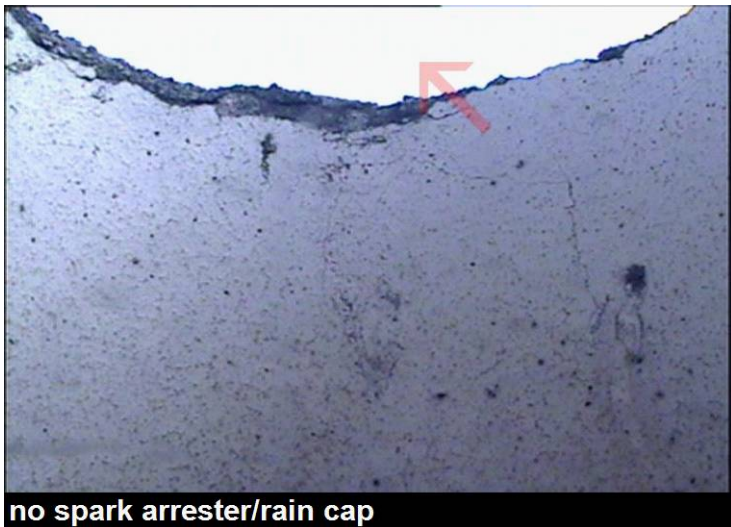
### SPARK ARRESTER:

Fire Safety Risk, the chimney system is not equipped with a spark arrester, or cap.

It is recommended that a spark arrester with a rain cap be installed at the top of the flue.

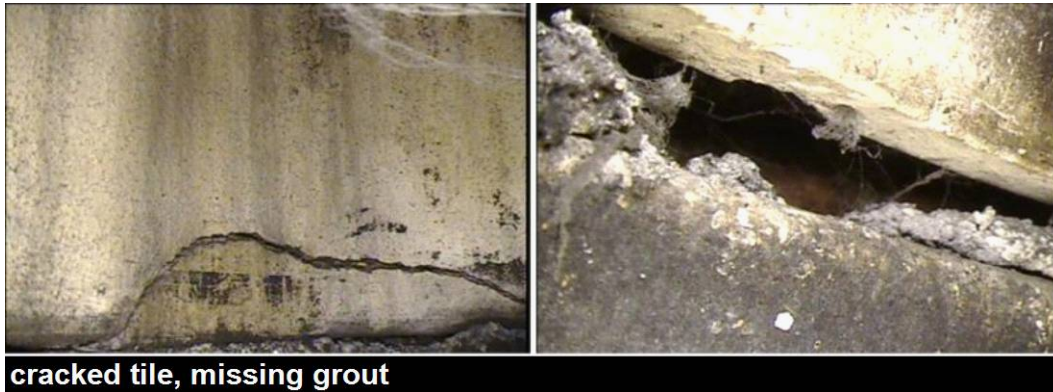
**FLUE CONDITION:**

Fire Safety Risk, there are cracked flue tiles noted within the clay liner system

Additionally, there is a lot of deteriorated/missing grouting between the flue tiles. This is considered a fire safety concern as the chimney system is not considered to meet the original design requirements intended to ensure that heat and combusted gases do not pass through the flue system.

It is my recommendation that a stainless steel liner be installed within the flue system.

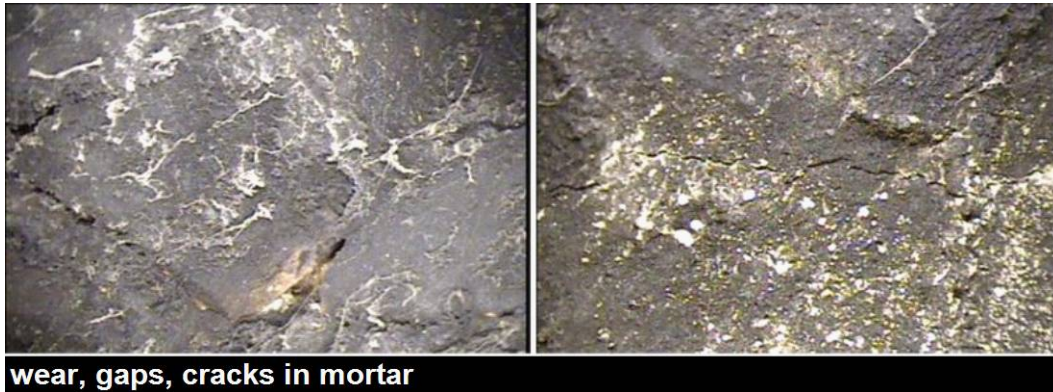
**SMOKE CHAMBER:**

Fire Safety Risk, the smoke chamber area has general wear and deterioration noted to the inside surfaces. This is considered a potential fire safety concern.

It is recommended that the smoke chamber be parge coated (a minimum 5/8 layer of fire rated mortar be applied to the smoke chamber and areas above the firebox) and any gaps, voids or deteriorated areas be smooth coated and filled with the same fire rated material.

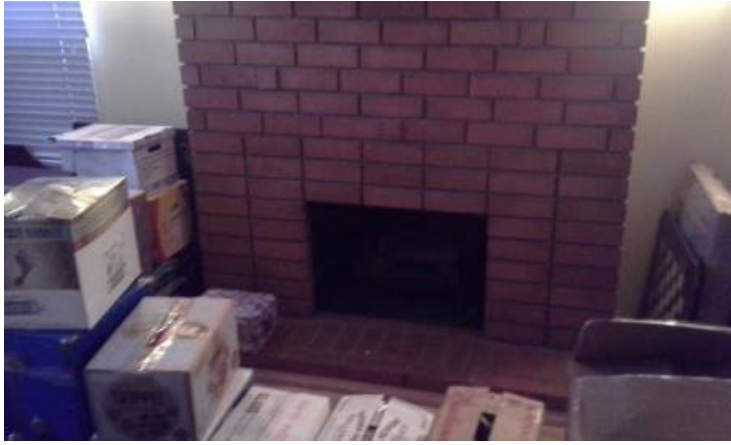
**FIREPLACE TYPE:**

This is a masonry wood burning fireplace, with a gas log lighter.

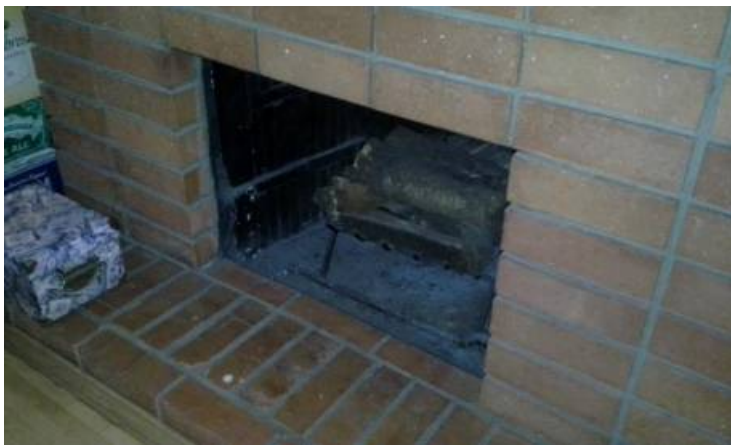
**FIREBOX CONDITION:**

Fire Safety Risk, there is a gap between the lintel and the brick finish over the fireplace. This gap should be sealed for fire safety.

Operational Concern, there are smoke stains along the firebox which usually indicates improper drawing of the chimney (and smoke entry into the house) during operation of the fireplace.

The back wall of the firebox is fairly forward (in relation to the throat) which can limit drafting and "thrust" the products of combustion into the living space. This is a poor design for drafting of the firebox.

The firebox throat area should be "opened up" by partial removal of the rear wall to help with the upward flow of combusted fuel through the throat and out the top of the chimney system.

All gaps and deteriorated areas above and within the firebox should be sealed with an approved fire rated material.

All the repairs to the system should be performed and then the fireplace operated during differing climate conditions to determine whether or not a smoke guard is needed.

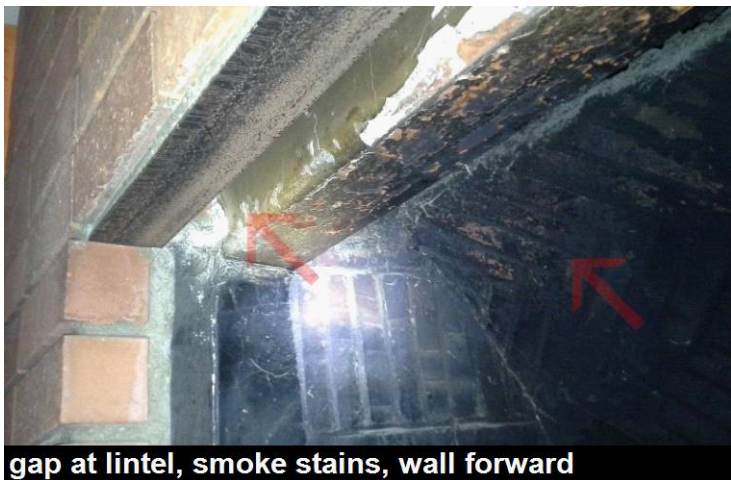
**DAMPER:**

There is no damper installed. This is not necessarily a requirement for this fireplace but a damper installation can help with energy conservation when the fireplace is not in use.

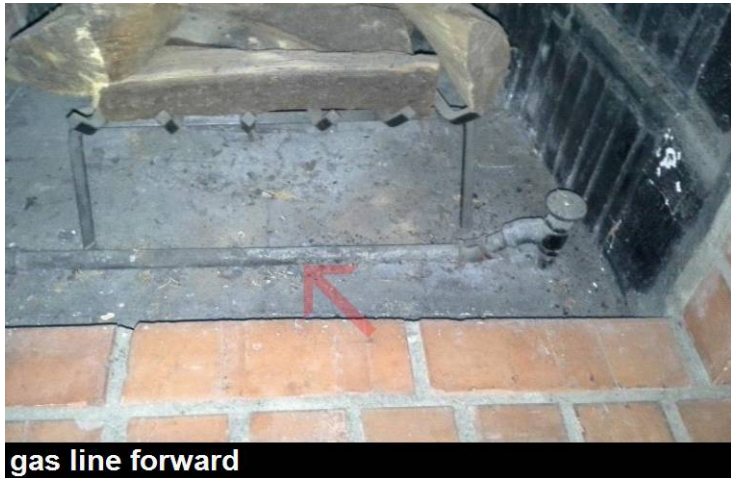
**GAS LINE IN FIREBOX:**

Fire Safety Risk, the log lighter is positioned too far forward within the firebox area (this installation can allow for gases to enter the living space due to the gases drifting outside the firebox). It should be positioned toward the middle rear of the firebox.

It is advised to reposition the gas log lighter towards the middle/rear of the firebox.

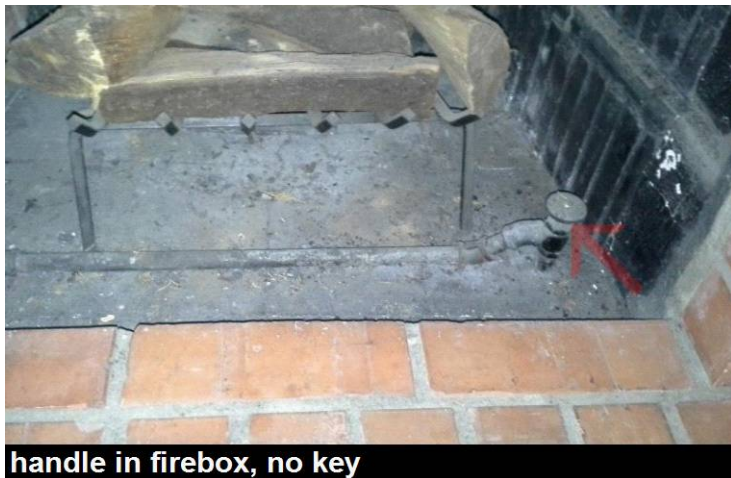
**GAS VALVE:**

Fire Safety Risk, the on off control valve is located just within the firebox area. The on off control valve should be located outside of the firebox. This valve is also older.

Additionally, the gas is turned on with a handle and not a key. This could be used by a child to turn the gas on. A key is preferable as it can be placed in a position where it cannot be easily reached by a child.

A gas valve requiring a key should be installed outside the firebox area per city standards.

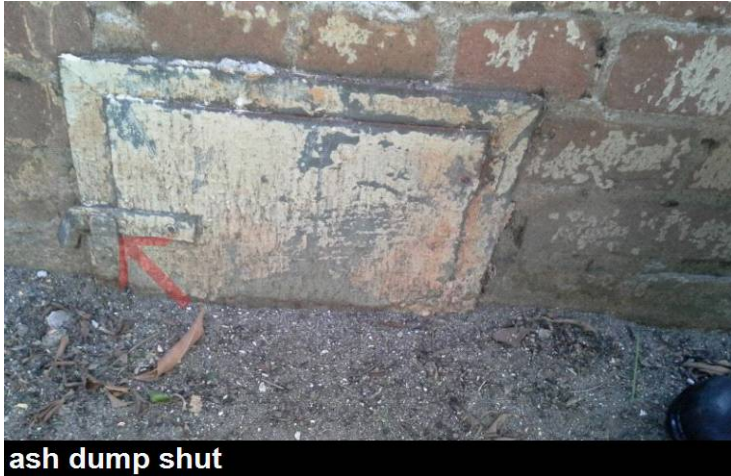
Needs Attention, the exterior ash dump door is not operable at this time, it is sealed or rusted shut.

ash dump shut

Repairs to the ash dump system are optional.
