# Real Estate Inspection Report

January 09, 2015

## Isabelle and Daniel March

**326 N. Ogden Drive  
Los Angeles, CA**

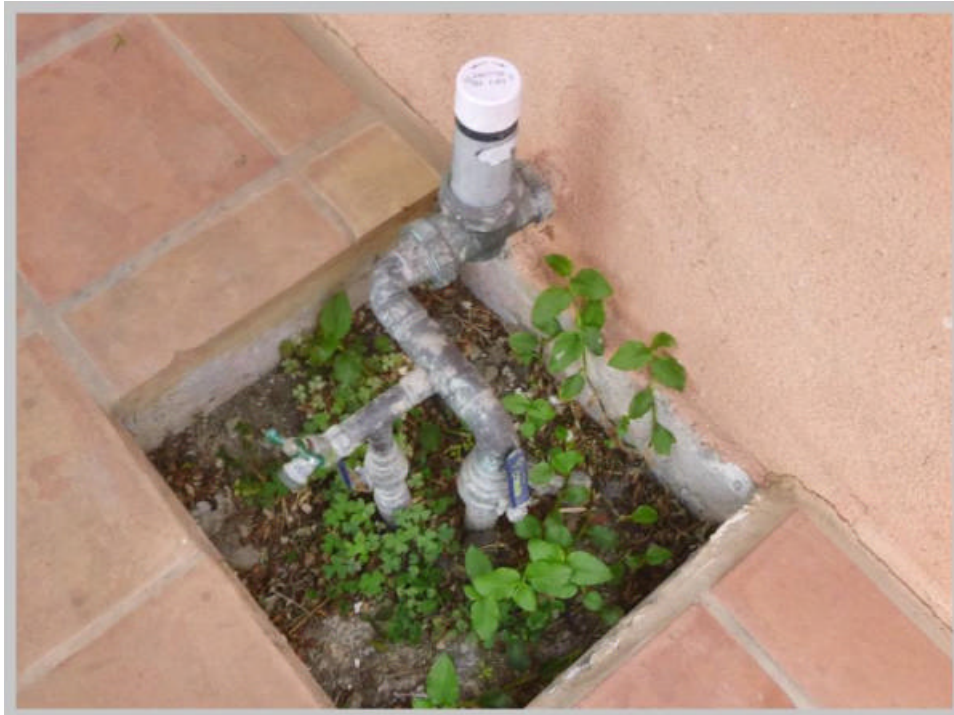
In the front of the building.

Serviceable .

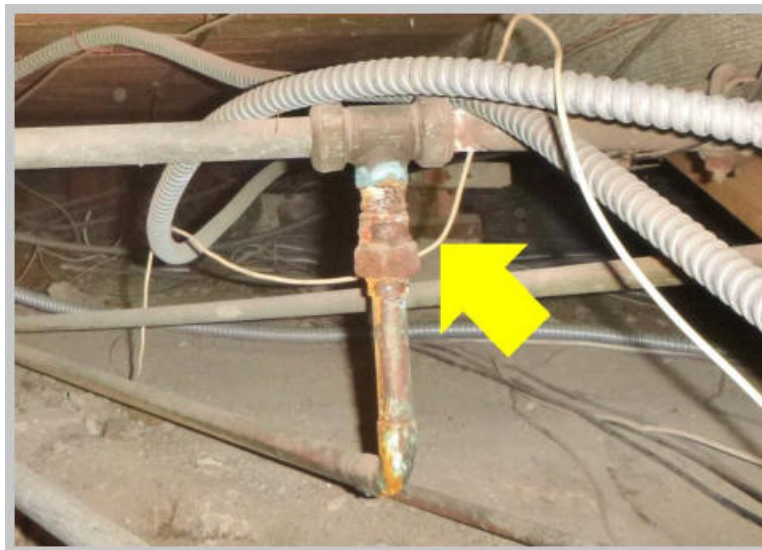
**Needs Attention: The original galvanized steel pipes are rusting, corroded and are showing deterioration. These are nearing the end of the useful life and will need to be replaced in the future as these wear out. It is not possible to determine exactly when these will need to be changed out.**

**There are extensive areas of non-insulated water supply piping, such as in the crawl space area.**

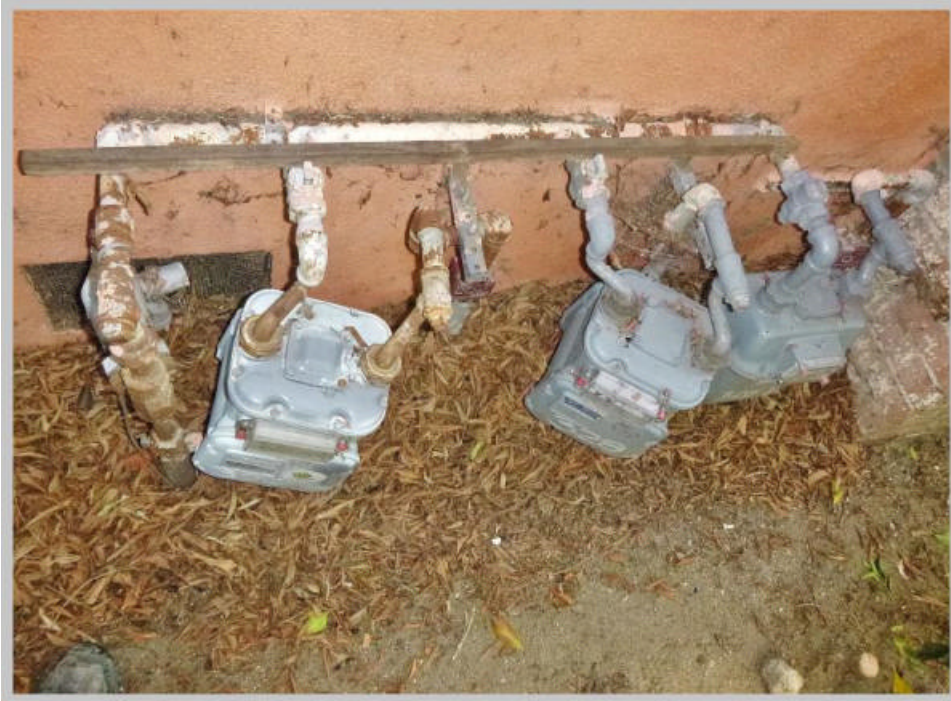
The three gas meters are located on the left side of the building.

It is advised to have the gas provider inspect the gas system to determine the condition and check all the gas appliances and fixtures. This is usually a free service.

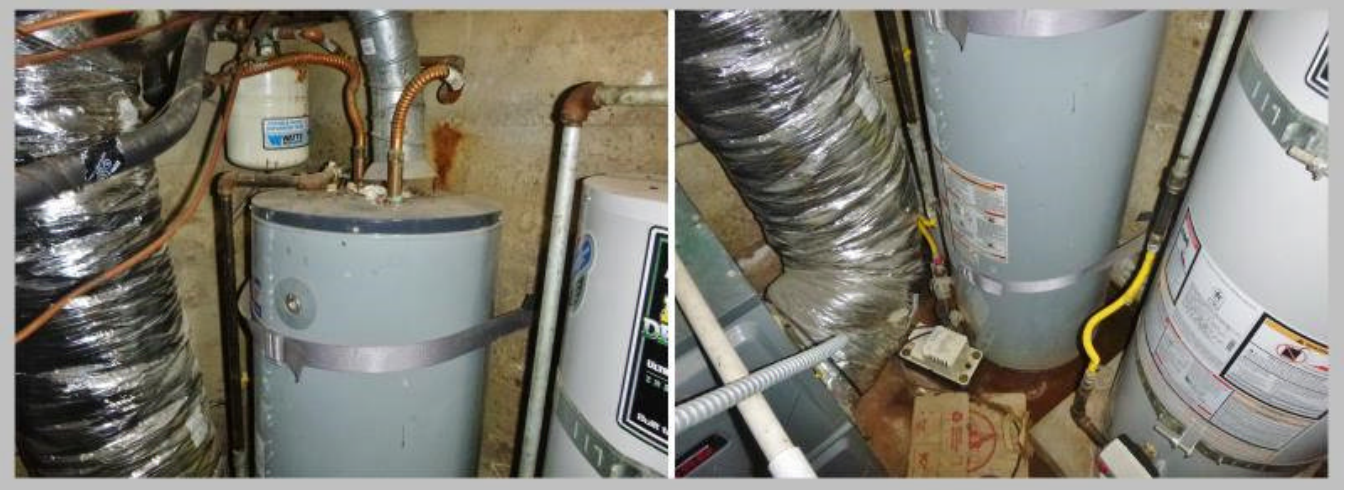
**Not Acceptable: The water heater is leaking at the base.**

**Needs Attention: There is rust and corrosion on the pipes at the top of the water heater. These may need to be replaced soon.**

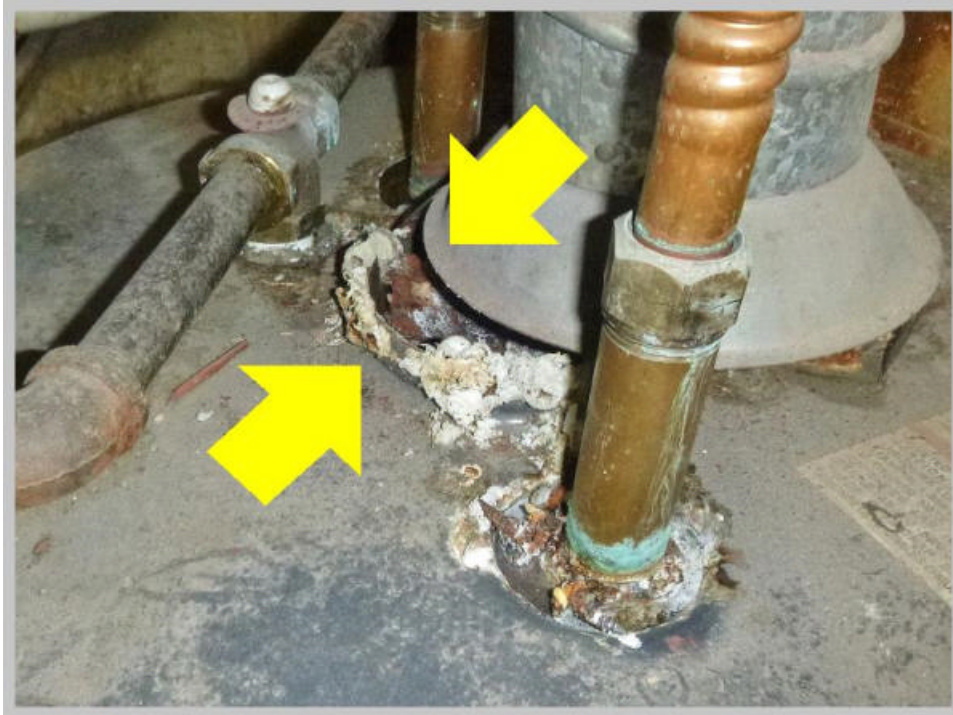
**Not Acceptable: The exhaust vent line is disconnected and exhaust gases from the water heater are escaping. This is a safety hazard and needs to be repaired.**

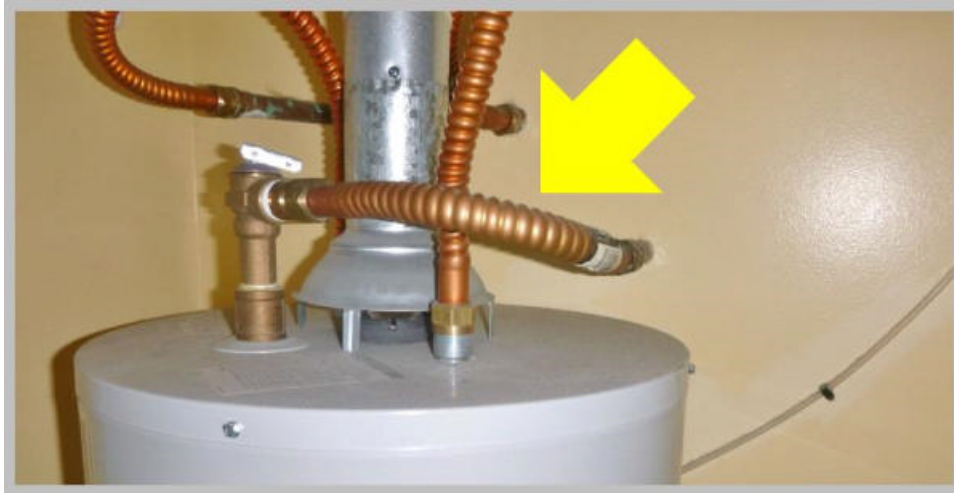
**Not Acceptable: The temperature/pressure relief valve line has restrictive piping in the line. This must be approved material, so it does not malfunction.**

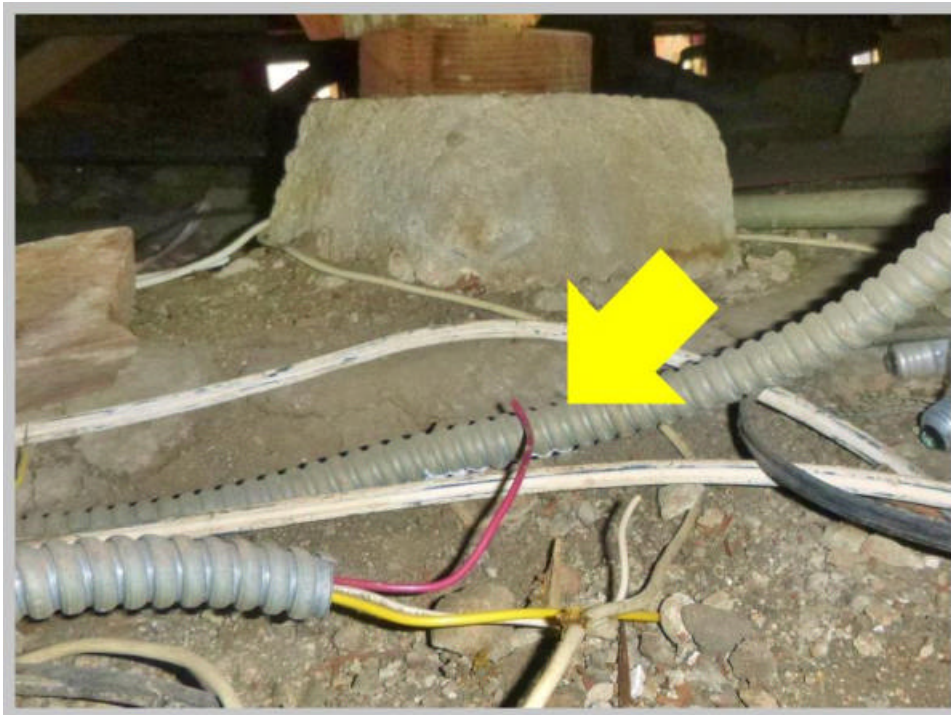
**Not Acceptable:** There are some wiring connections in the building that are not made within junction boxes, such as in the crawl space area. These connections have exposed wires and are not standard. This is a safety hazard and the wiring needs to be installed properly.

**Needs Attention:** There are several areas of dangling wiring that are not properly secured to the framing.

**It is advisable to have an electrician examine the system and make all needed repairs to ensure a properly installed and correctly operating electrical system.**

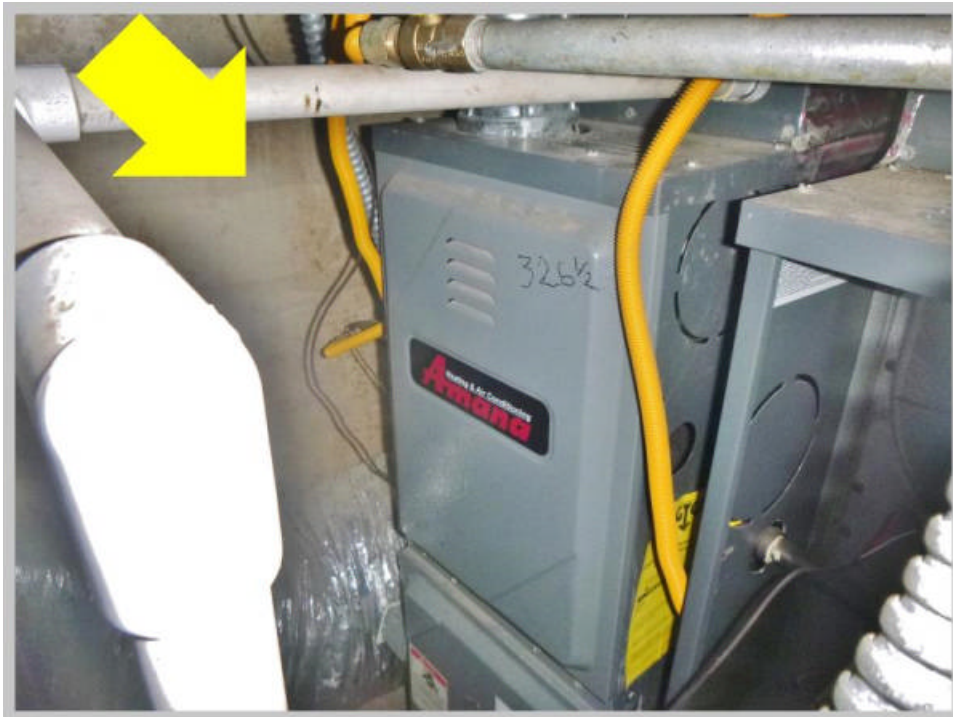
The heating unit is located in the basement.

**Not Acceptable:** There is inadequate access space provided for service and maintenance of this unit.

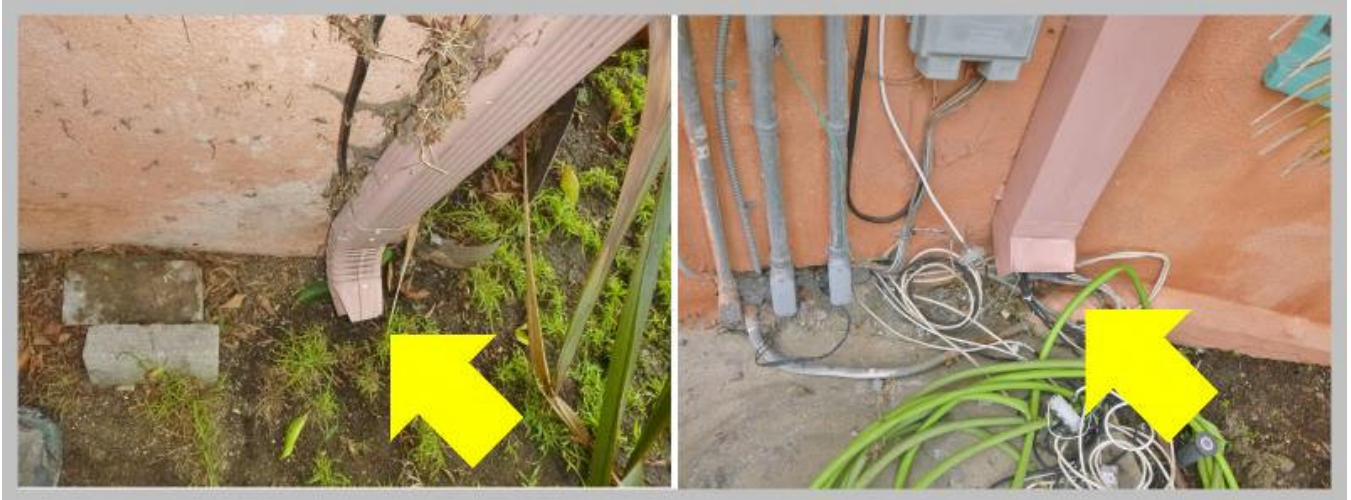
**Needs Attention: The downspouts do not all route the water away from the building but instead deposit it next to the structure which can cause problems to the foundation over time.**

**It is advisable to have a licensed roofer examine the entire roofing system and make all needed repairs to ensure a properly installed and correctly operating roofing system.**

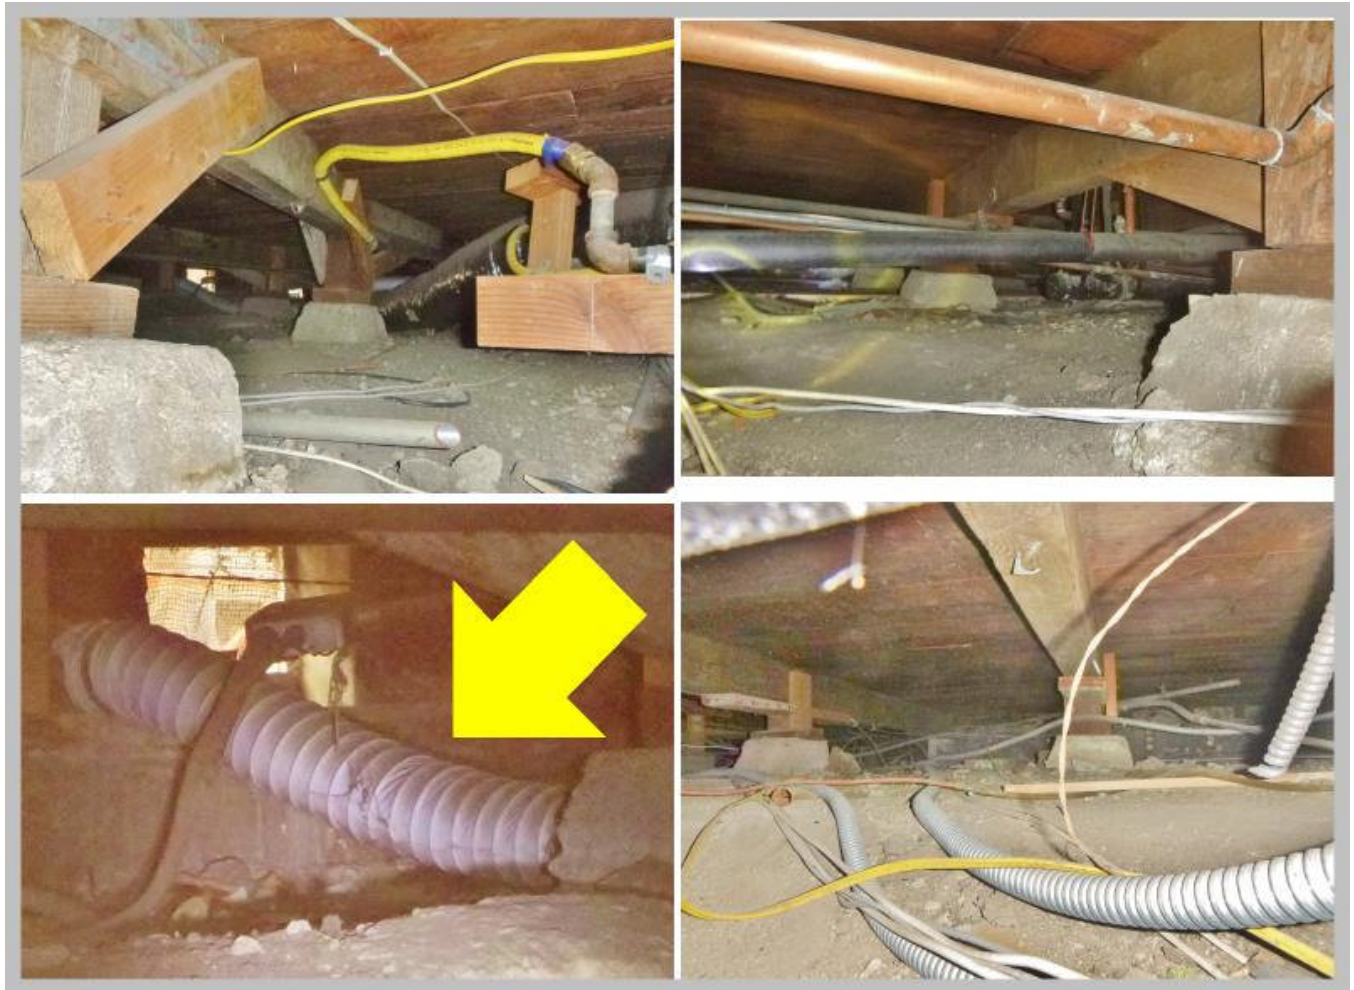
**Not Acceptable: Flexible ducting is being used in the crawl space area (this duct material is only allowed to be used inside the immediate laundry area at a length of not greater than six feet). This should not pass through walls/floors or be installed in the crawl space, garage or exteriors. Smooth wall metal duct should be used.**

**Needs Attention: The crawl space is not tall enough to enter in areas, such as at the left side, the right side and the rear. 18 inches of space is required for safe access and this is less than that.**

There were evidence of rodents observed under the structure. It is advised to have this checked out by a specialist to determine the extent of their presence.

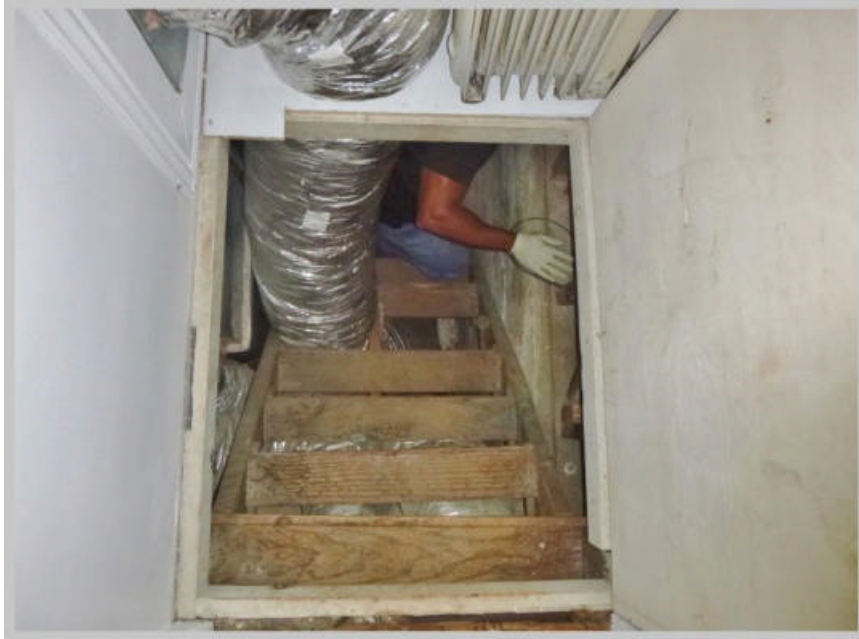
**Not Acceptable: The steps to the basement are damaged and a hazard in the current condition.**

**There is no railing on the basement stairs, all stairs require a handrail and one should be installed for safe access.**

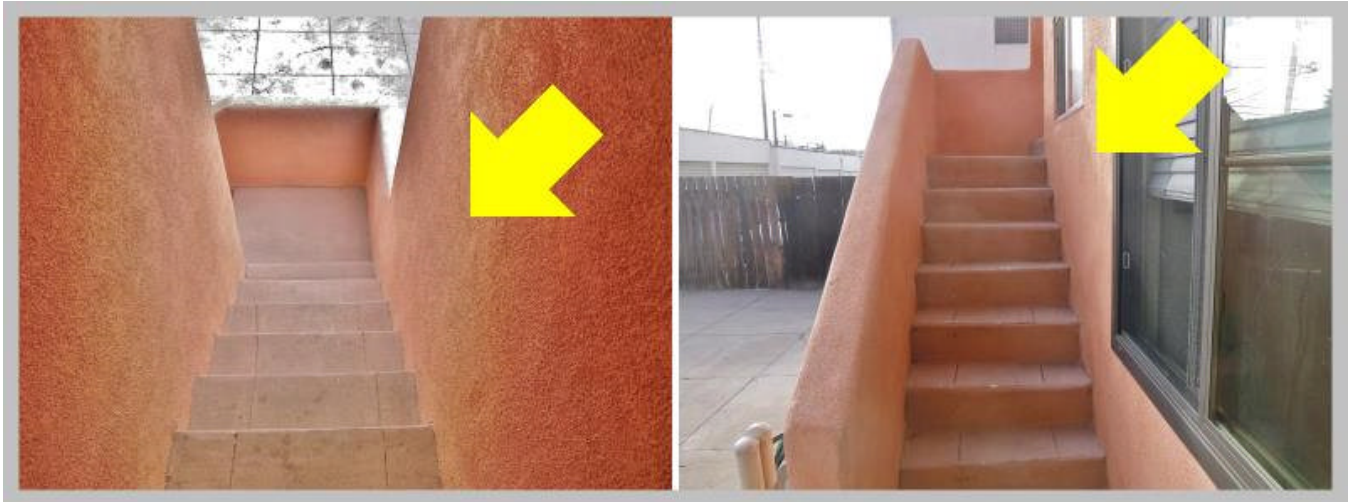
**Not Acceptable: There is no handrail installed for the rear entry stairs. This is recommended for safety.**

Serviceable, for the balcony railing.

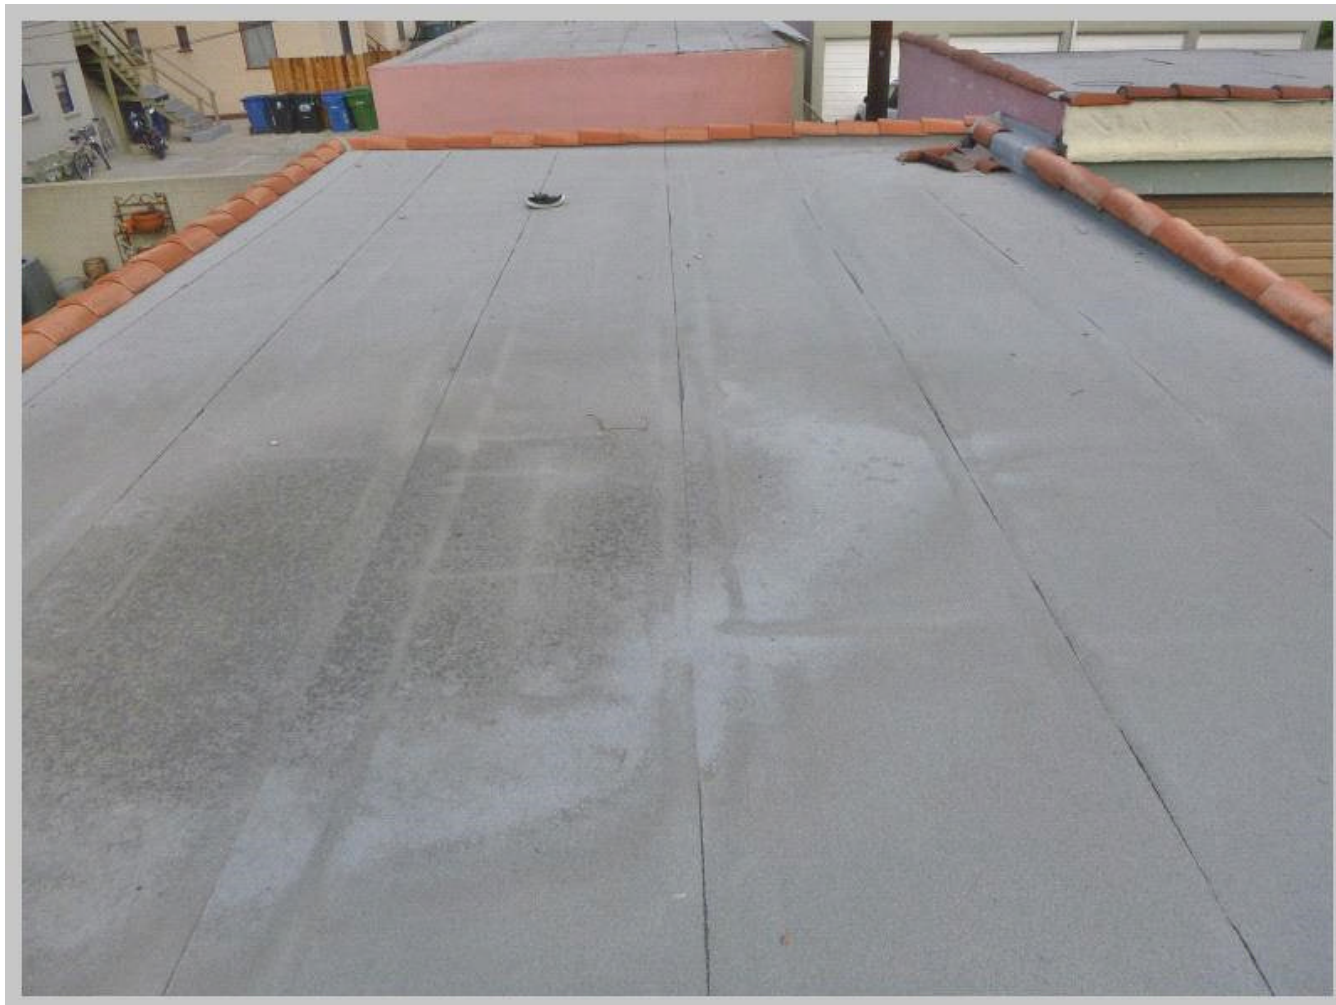
The roof is a flat roof, with a low pitch.

The roofing material on the low sloped roof is rolled composition roofing.

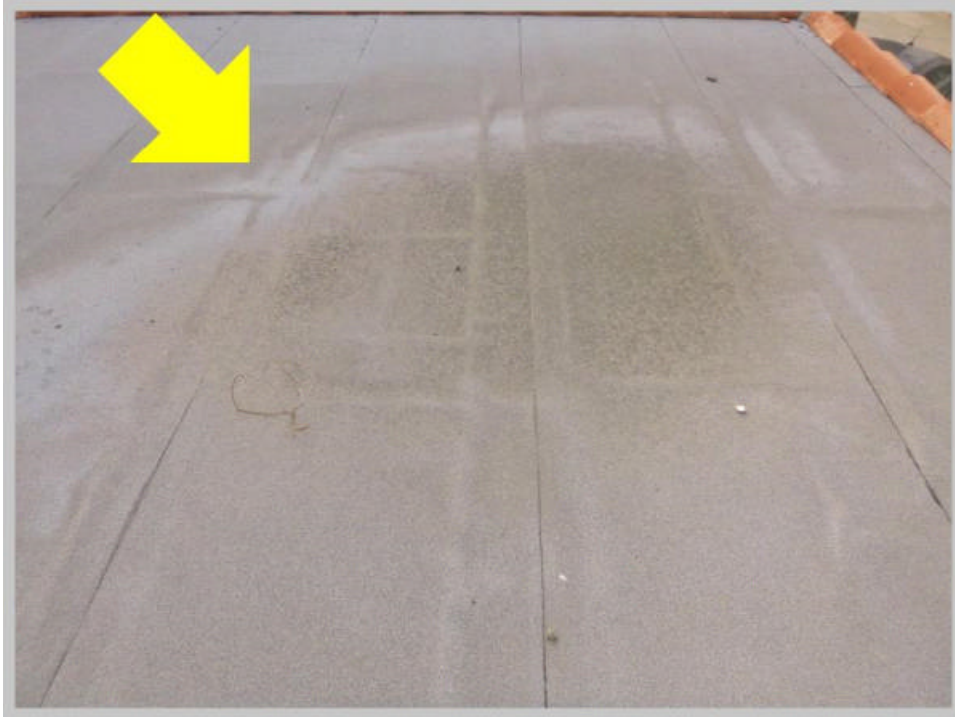
**Needs Attention: On the low sloped/flat roof There are areas were the roof is poorly sloped and water collects and ponds and does not fully drain off. This can lead to premature wear and failure. A roofing specialist may be able to remedy this.**

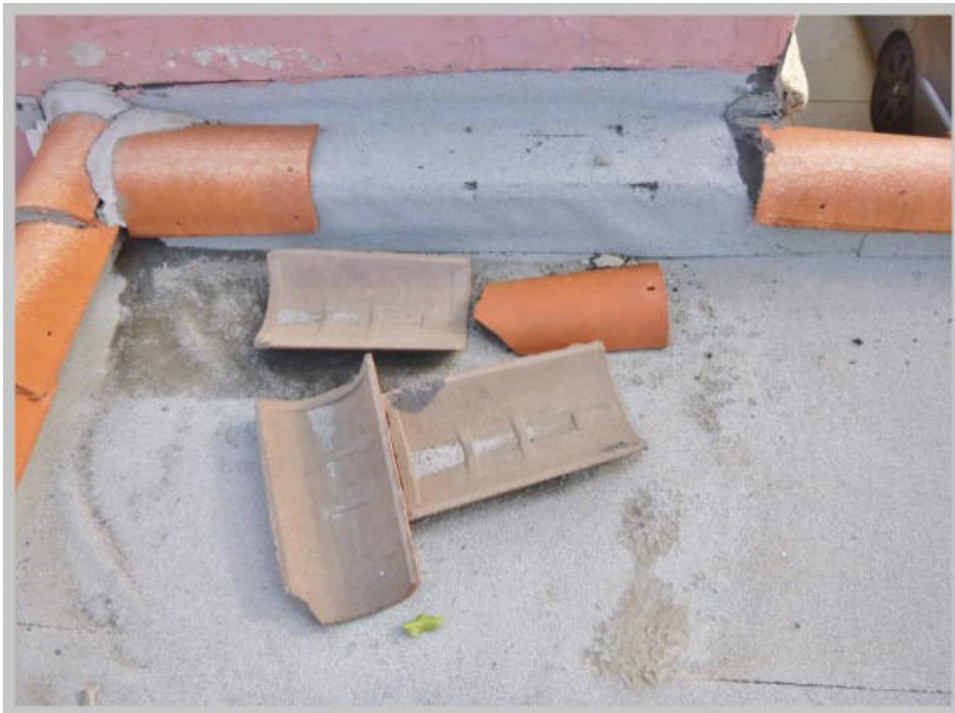
**Not Acceptable: There are displaced and missing coping tiles. These can allow moisture intrusion to occur.**

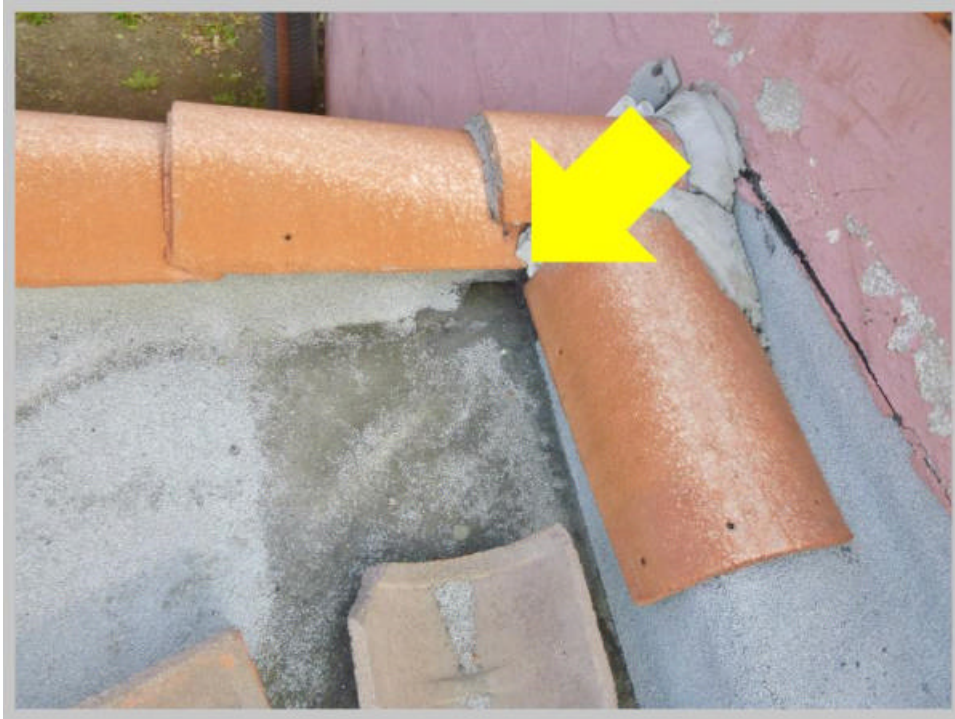
There appear to be 'scupper' drains through the side (parapet) walls of the building to direct water off the roof.

Needs Attention: It is recommended a debris screen be installed around this drain to prevent the drain and downspout from becoming blocked.

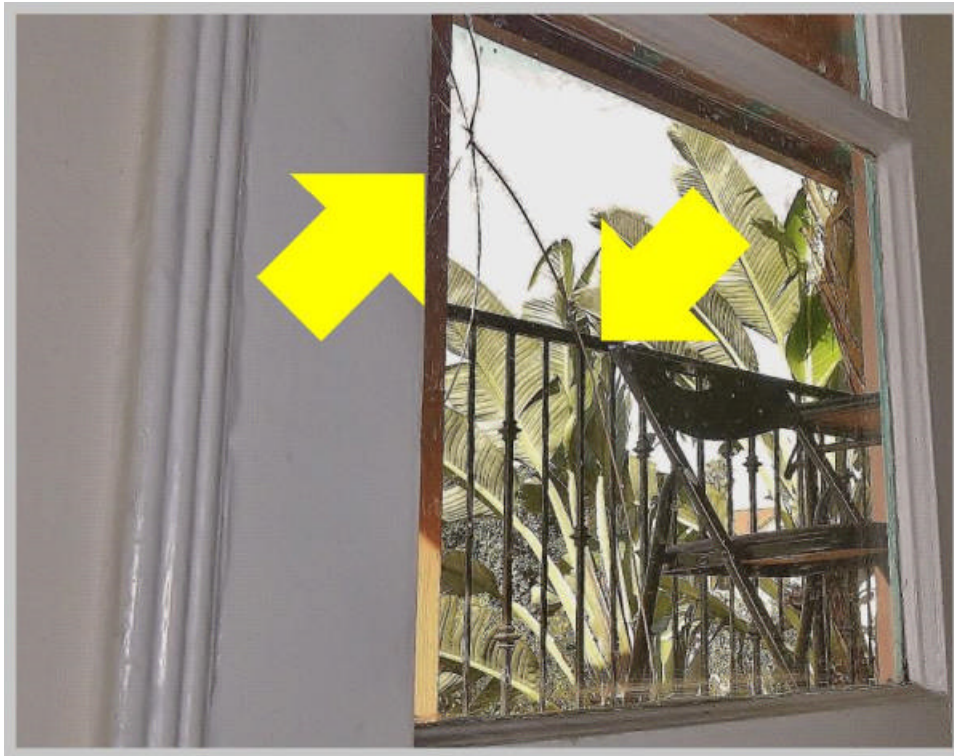
**Not Acceptable: There are cracked window panes in the entry stairway.**

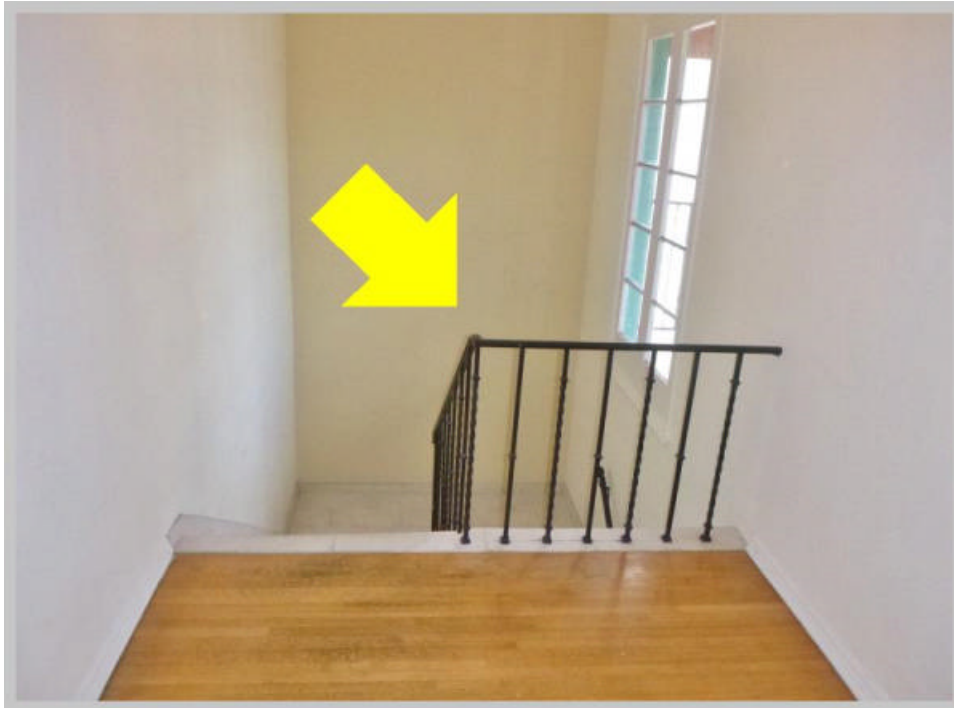
**Needs Attention: The space between the rails is greater than is currently recommended for child safety. The railings should not have any space greater than four inches in any portion.**

**The railing is not tall enough to meet the current safety standard for railing height.**

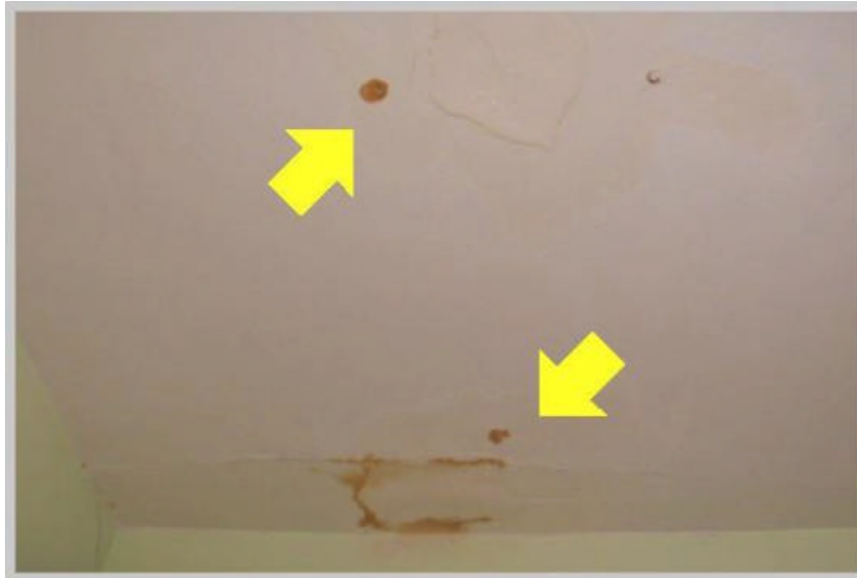
**Needs Attention:** There are areas of moisture stains on a closet ceiling.

**The flooring has areas of sloping as from building settlement.**
