# Real Estate Inspection Report

**6413 Willoughby Ave.  
Hollywood CA**

Inspector - Lou Fossessa  
Confidential and Proprietary

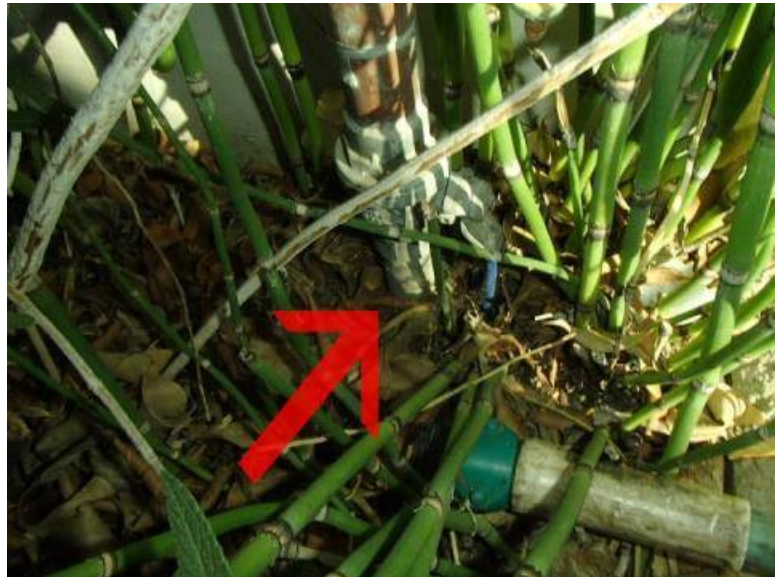
MAIN WATER LINE MATERIAL:

Copper piping is viewed coming out of the ground by the building and as the main line runs underground from the street to the building, this appears to be the main water line. As the underground portion is not seen, no representation is made or implied as to its condition or material.

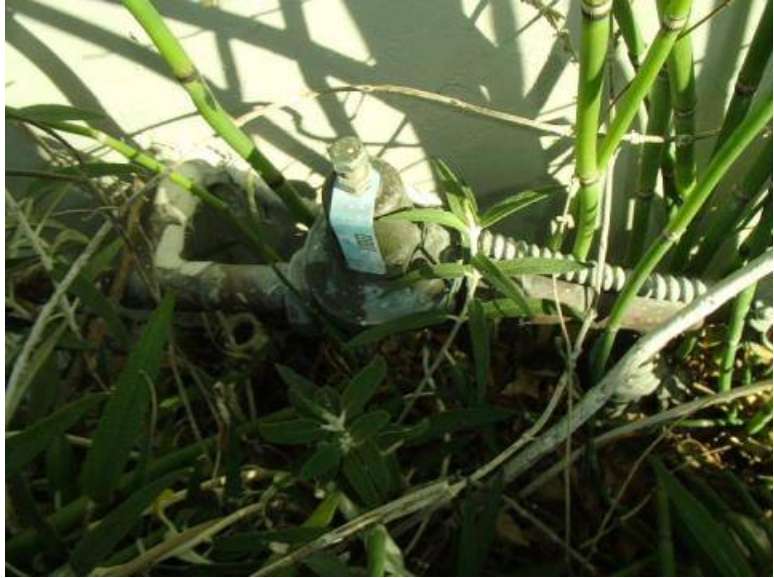
CONDITION:

There was a pressure regulator observed on the water supply system. As this is a closed system, its internal components are not visible. No representation is made or implied as to the pressure regulators operation or condition.

**Not Acceptable. The pressure is over 80 psi. This is too high (115 psi), it should be between 40 and 80. The pressure regulator should be adjusted or replaced to bring this down into proper range.**

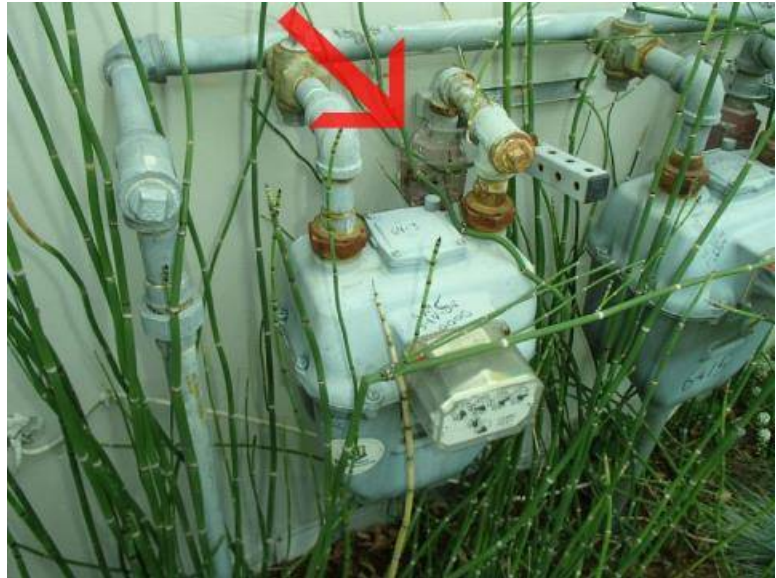
SEISMIC GAS SHUT OFF  
VALVE:

There is an automatic seismic gas shut-off valve installed on the main gas line. It is beyond the scope of this general inspection to determine its operating status or if it has been sized correctly for this gas system. If further information is desired or required it is advised to consult a qualified plumbing contractor.

CONDITION: **Not Acceptable. The smell of gas was noticed, this is not acceptable and may indicate a gas leak. It is advised to have the Gas Company inspect the gas system and determine its condition immediately.**

It is advised to have the gas provider inspect the gas system to determine its condition and check all the gas appliances and fixtures. This is usually a free service.

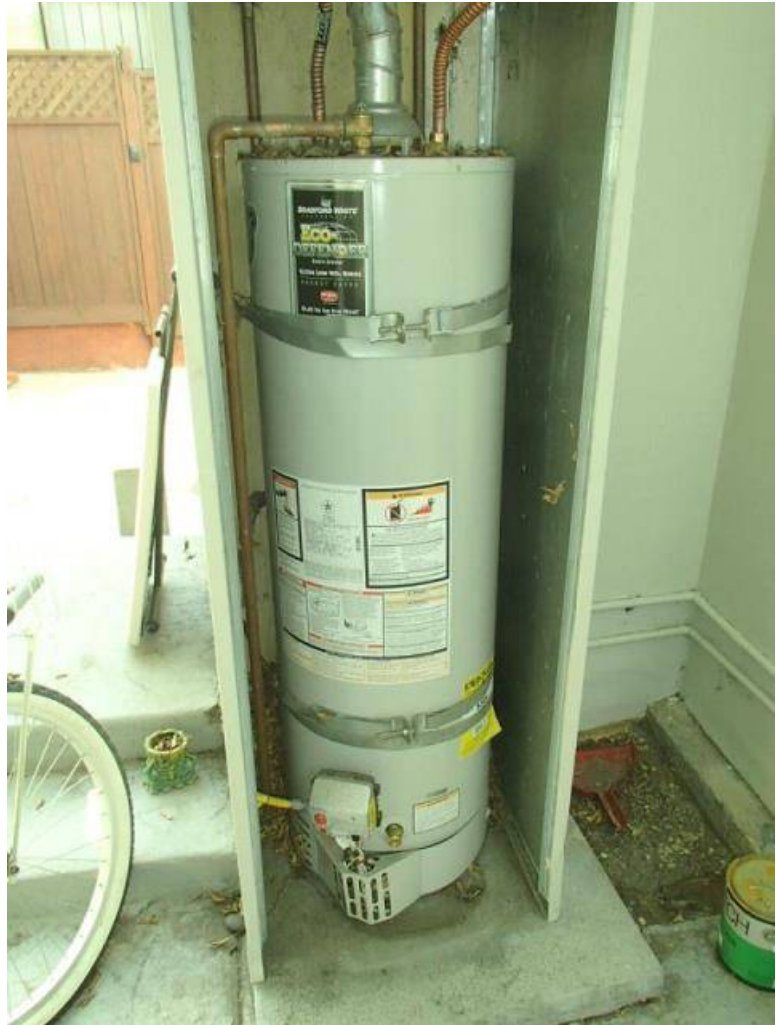
LOCATION:

The water heater is located on the exterior of the building at the back, in a metal shed.

LOCATION CONDITION: **Needs Attention. The door to the water heater is in poor condition.**

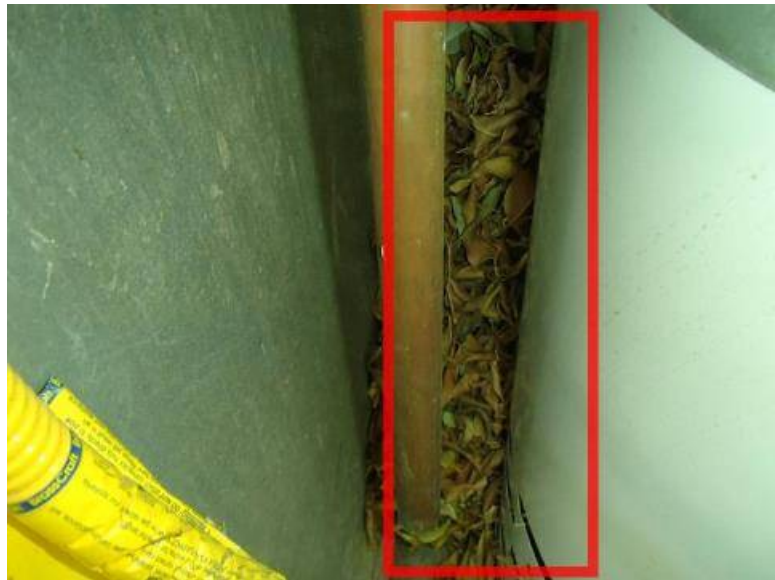
COMBUSTION AIR:

**Not Acceptable. The vents supplying combustible air are blocked by leaves.**

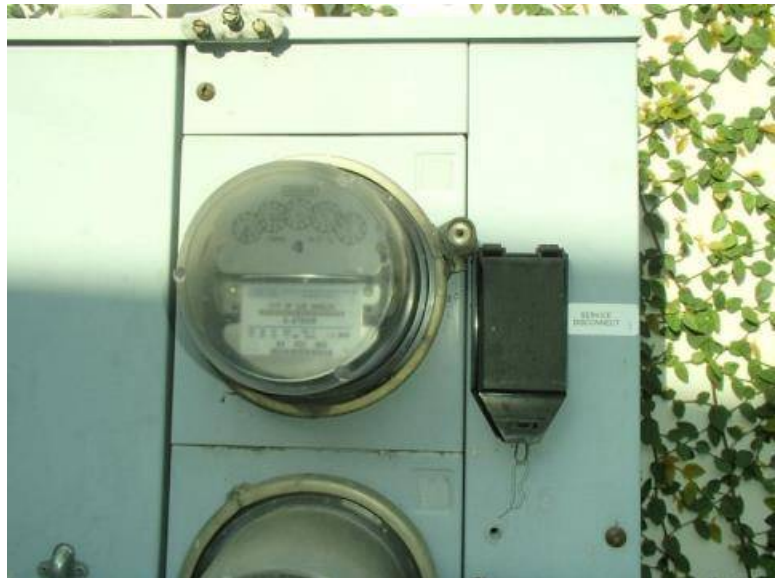
MAIN PANEL LOCATION:

The main electrical panel is located on the right exterior side of the building.

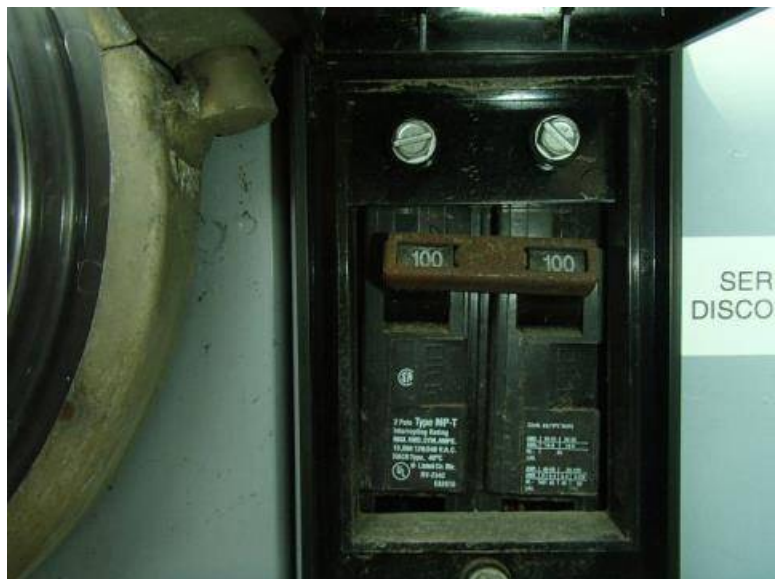
MAIN PANEL AMPERAGE:

Service Amperage - 100 Amps.

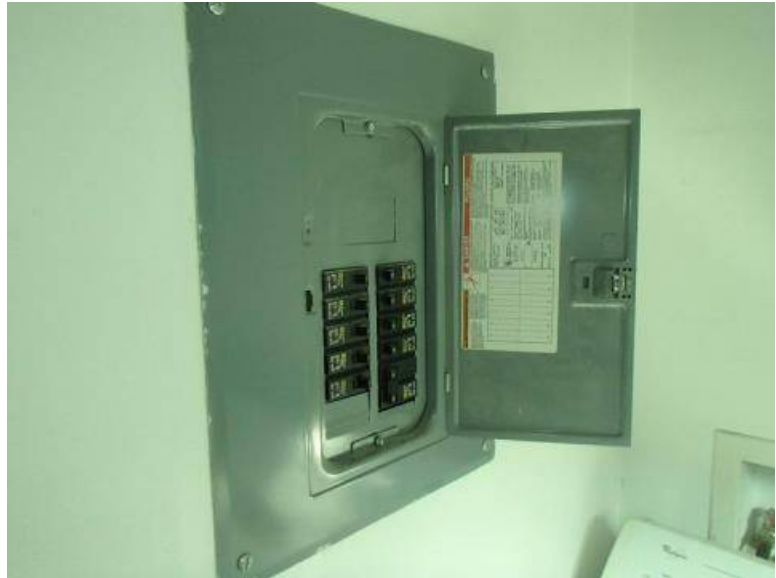
SUBPANEL LOCATION:

There is an electrical sub panel, in the utility room.

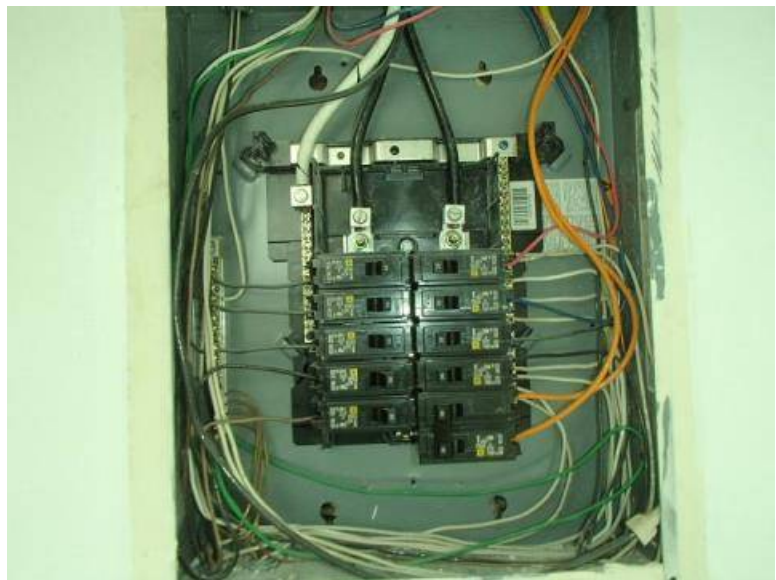
SUBPANEL CONDITION:

Serviceable.

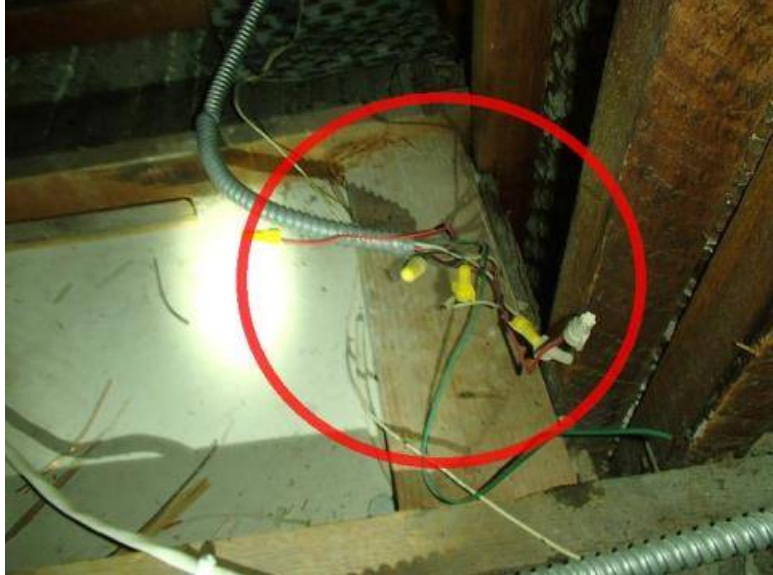
WIRING CONDITION:

**Not Acceptable: There are some wiring connections in the building that are not made within junction boxes. These connections have exposed wires and are not standard. This is a safety hazard and the wiring needs to be installed properly. Such as at the attic.**

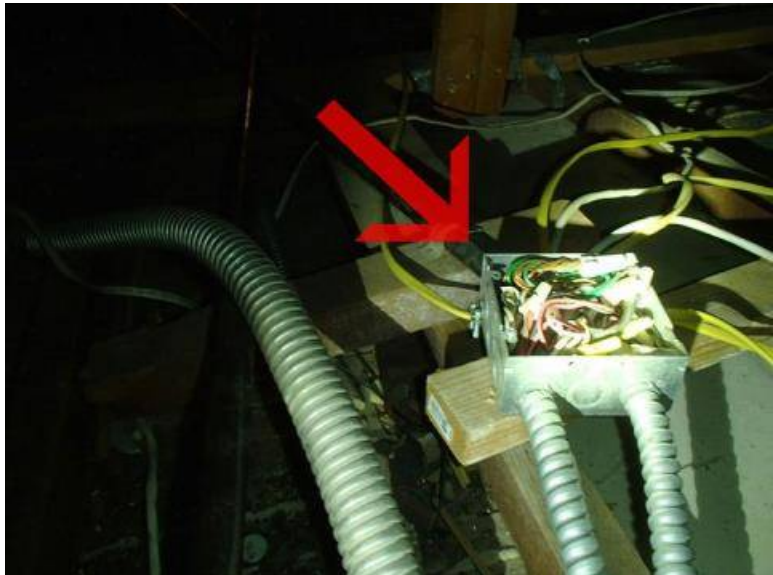
ELECTRICAL WIRING COMMENTS:

There are open junction boxes with wires exposed. These need to be completed and have covers installed for safety, and are found, in the attic.

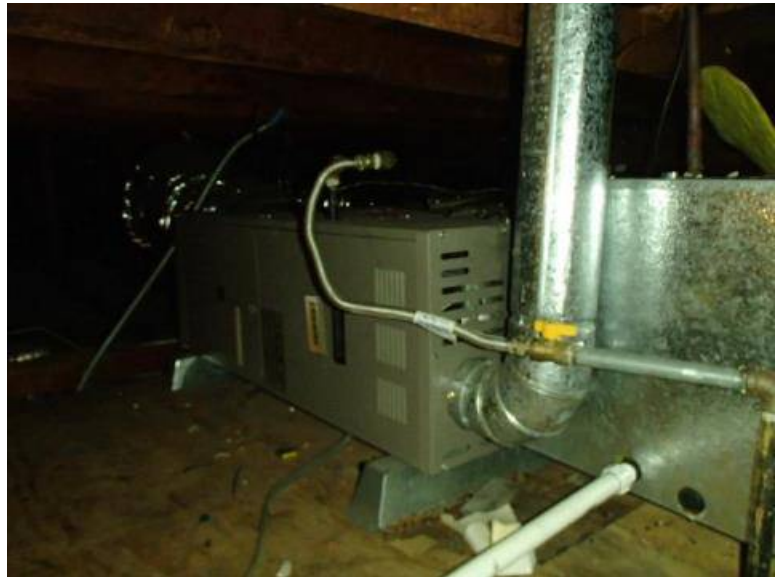
LOCATION:

The heating unit is located inside the building in the attic.

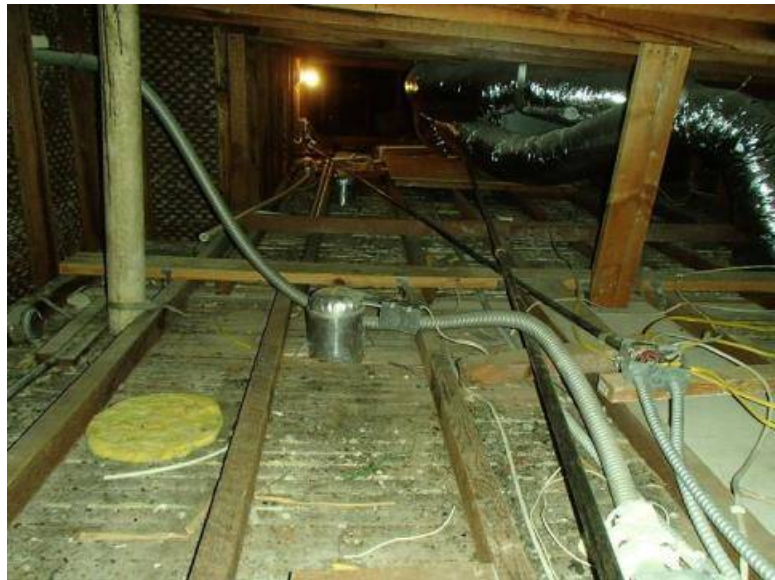
LOCATION CONDITION:

**Needs Attention, there is no cat-walk installed to access the furnace, this is a standard requirement for safe working conditions around the furnace.**

**There is no working platform installed to work on the furnace, this is a standard requirement for safe conditions around the furnace.**

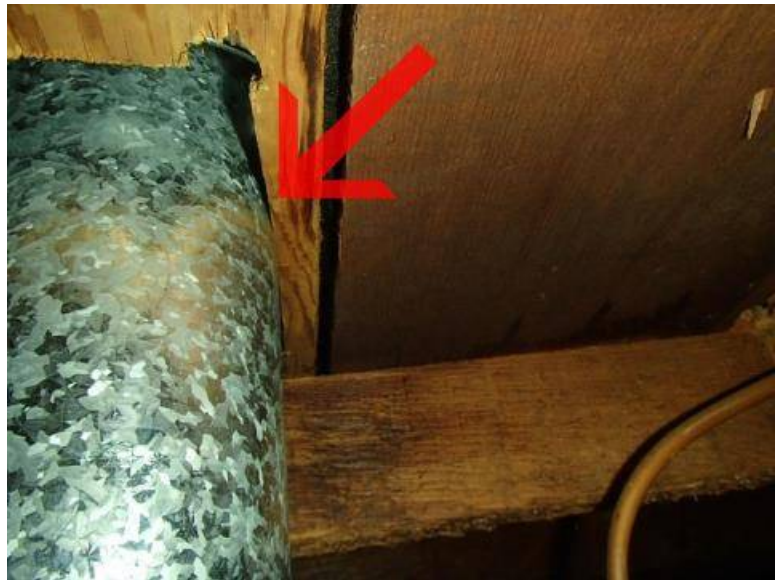
VENTING:

**Not Acceptable, the furnace vent pipe is too close to combustible materials. This is a hazard and the vent line needs to be repaired to have the proper clearances.**

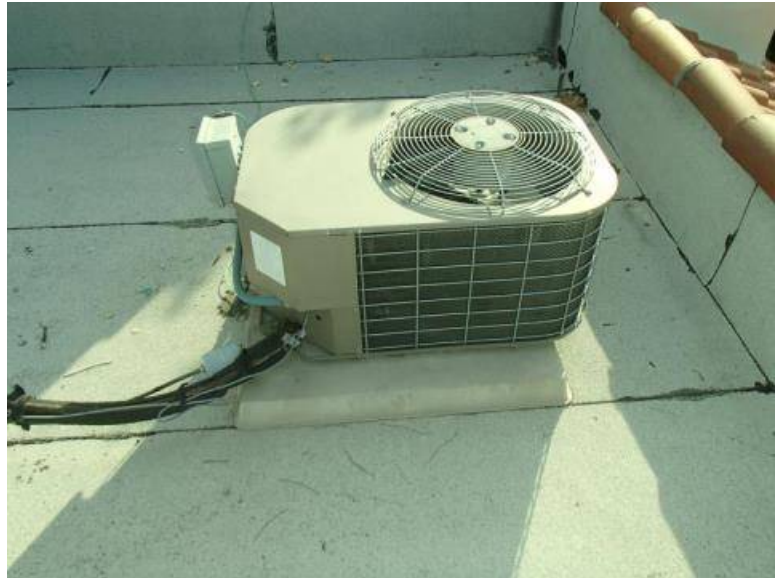
LOCATION:

The condenser for the air conditioning is located on the roof.

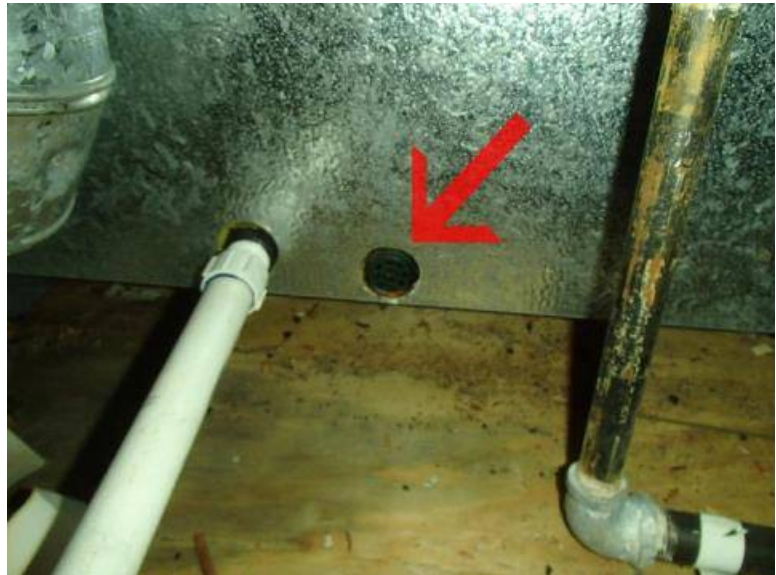
CONDENSATE LINE:

**Not Acceptable, there is no condensate pan installed. All air conditioning pulls moisture from the air and this moisture has to be taken somewhere. There is supposed to be a main condensate line to do this plus a back up pan with a secondary condensate line installed in case the primary line fails. The pan and its secondary**

**backup line is missing.**

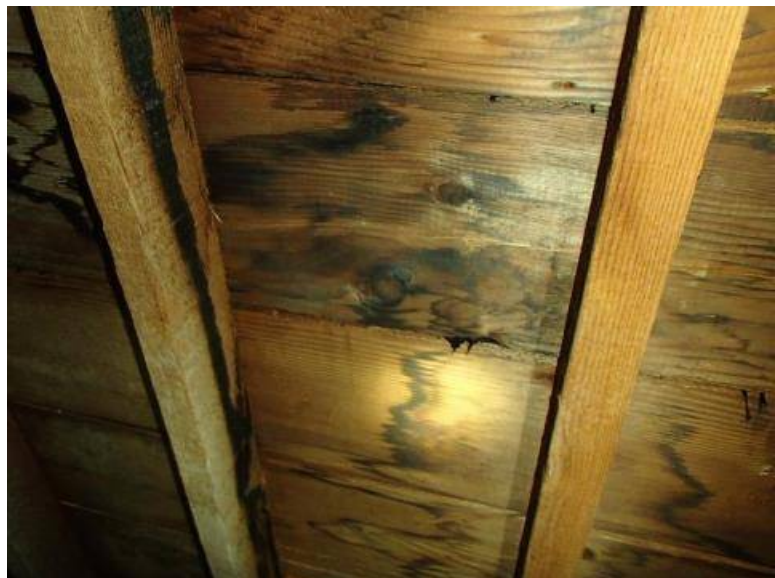
**ATTIC FRAMING  
CONDITION:**

**Needs Attention: There are areas of stains on the framing lumber these appear old and may be from a previous roof leak.**

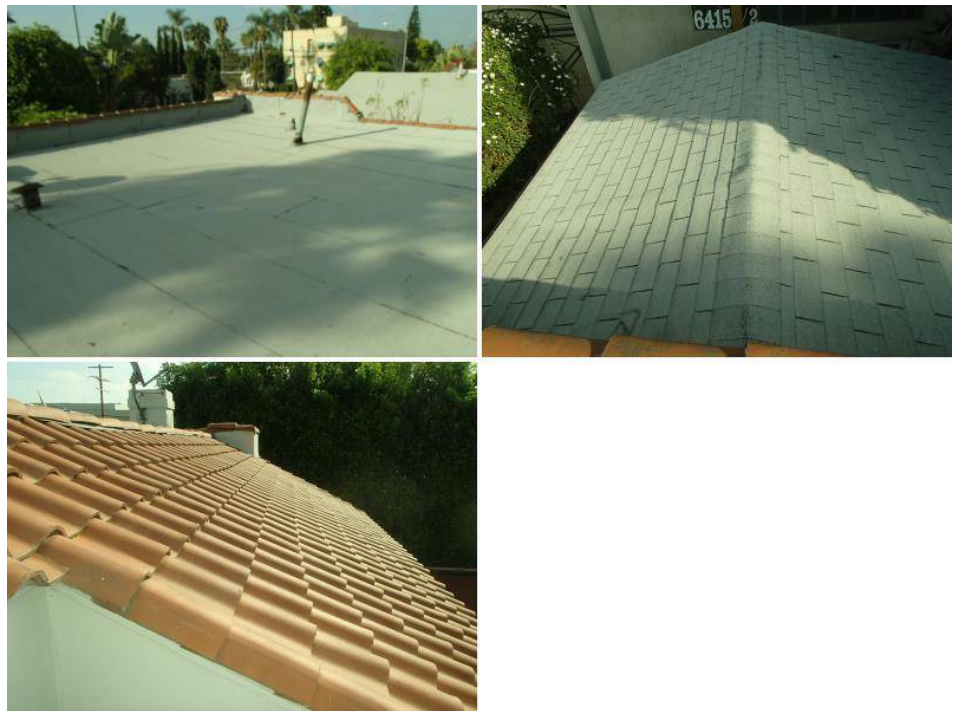
ROOF STYLE:

The roof is a combination of styles.

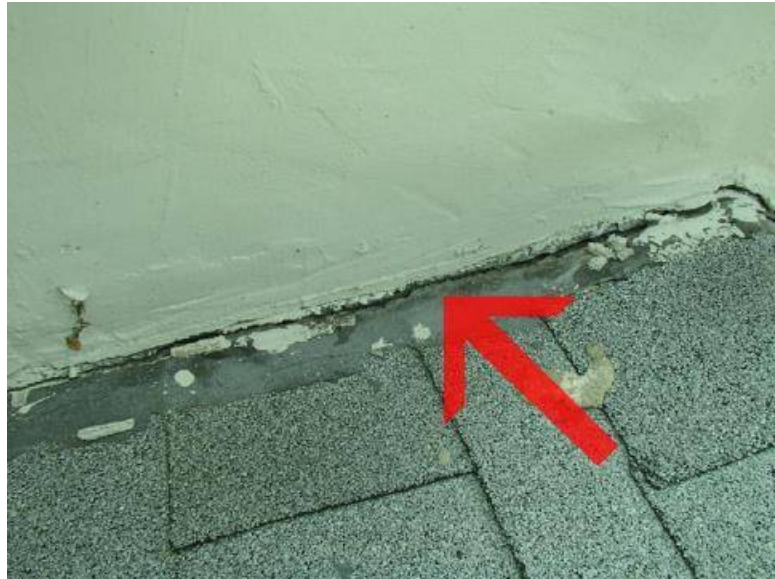
CONDITION:

**Not Acceptable: The connection of the roof to the wall of the building has not been properly flashed and therefore is not a reliable installation. It will require high maintenance in this state. Such as at the pitched roof.**

**Needs Attention: There are missing "roof Jack" metal flashings around some pipe penetrations through the roof surface. This is a poor and unreliable installation, and will require frequent maintenance and sealing, and may lead to leaks.**

**The mastic is cracked in areas and is not reliable to ensure a watertight seal.**

**A licensed roofing contractor should examine the roof and make all needed repairs (or replacements) to ensure a long lasting leak free condition. The roofing contractor may find more problems with the roof and this is why it is being referred to a specialist so they can determine all the problems and give an accurate estimate of the costs involved**

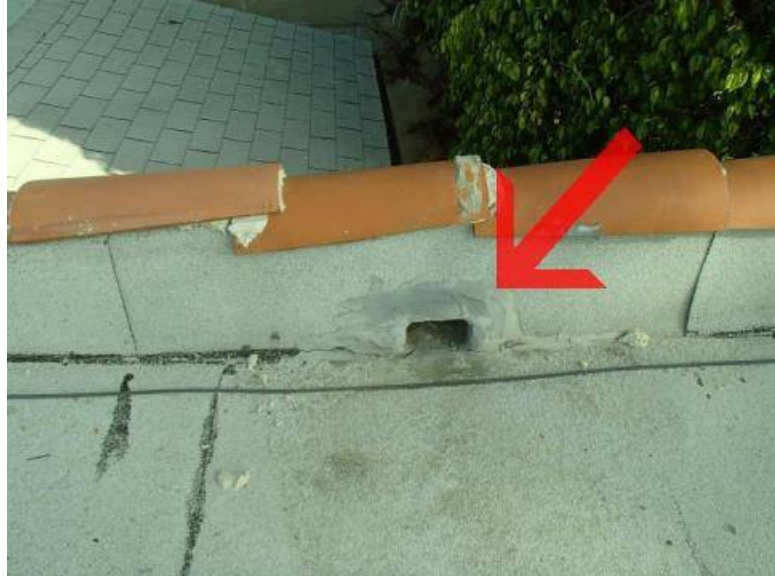
### GUTTER CONDITION:

**Needs Attention:** There are 'scupper' drains through the side (parapet) walls of the building to let water off the roof. It is recommended that an overflow scupper drain be added about 2 inches above the main drain to prevent ponding and flooding.

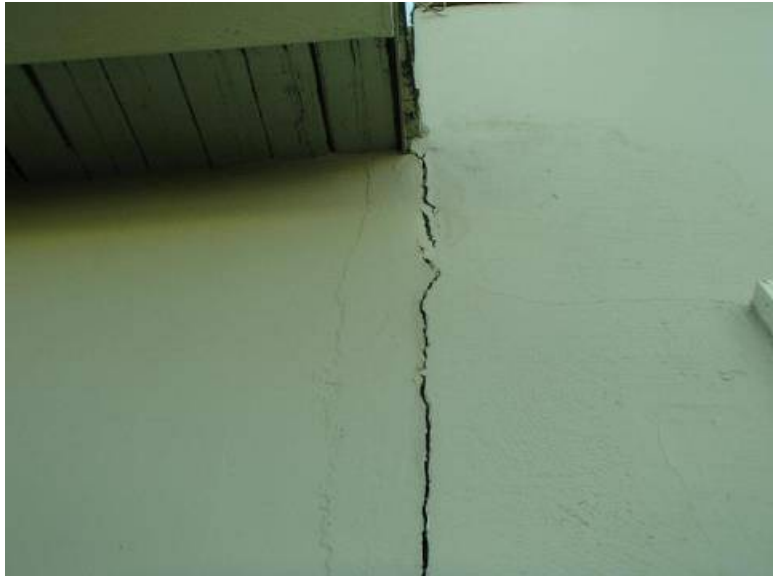
**CONDITION:**

**Needs Attention: There is a crack running down the left wall and repairs are needed to ensure there is no water intrusion**

**Otherwise, there is typical cracking in the exterior stucco.**

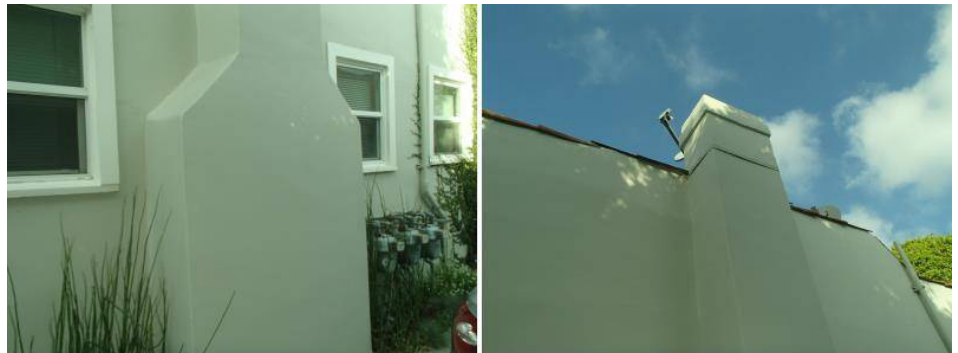
LOCATION:

This chimney is located at the. right side.

MATERIAL: The chimney is made of brick covered with stucco.

CONDITION: **Needs Attention: The chimney may be cracked. It needs to be evaluated by a chimney expert to determine its true condition.**

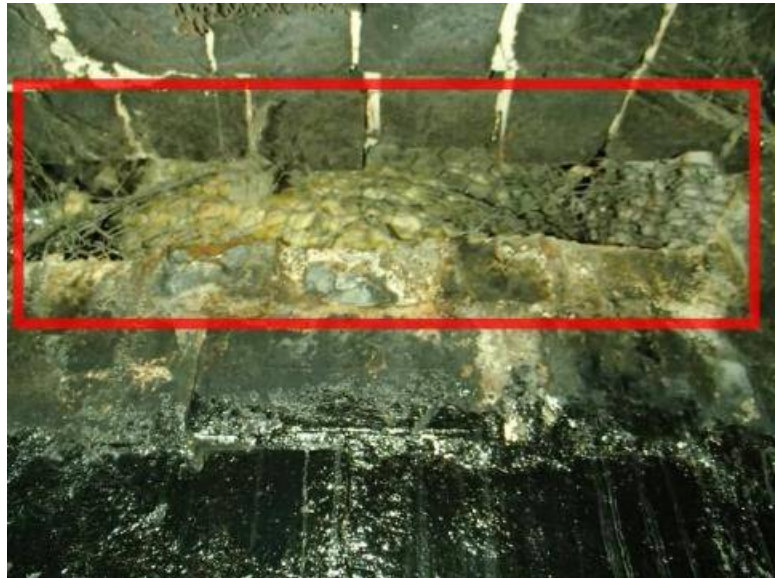
**FLUE:**

**Needs Attention: The flue is closed off with different materials**

Only a small area of the flue is visible and can be observed , the majority of the flue system cannot be viewed or evaluated in this limited general inspection. There is a real risk of concealed damage that may pose a fire hazard. It is advised that a chimney specialist with a video camera inspect the chimney and flue system fully to ensure safe operation and structural stability.

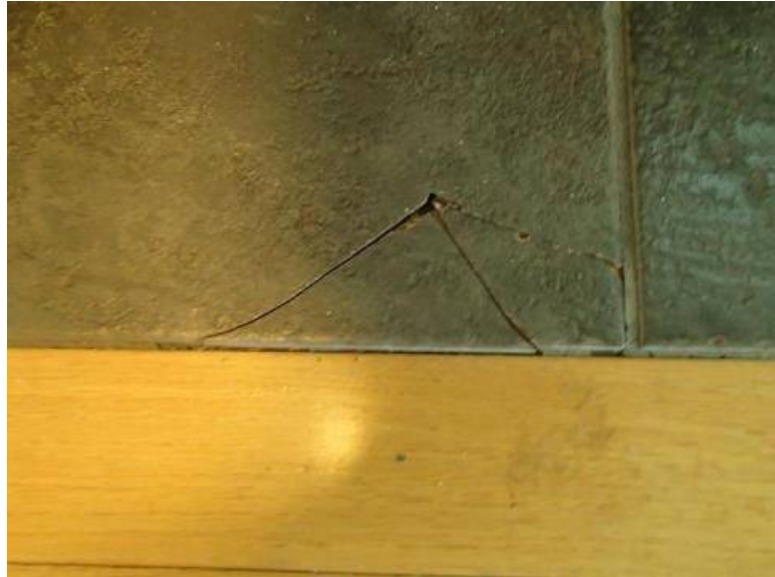
**MANTLE/HEARTH:**

**Needs Attention: The hearth has cracks in it.**

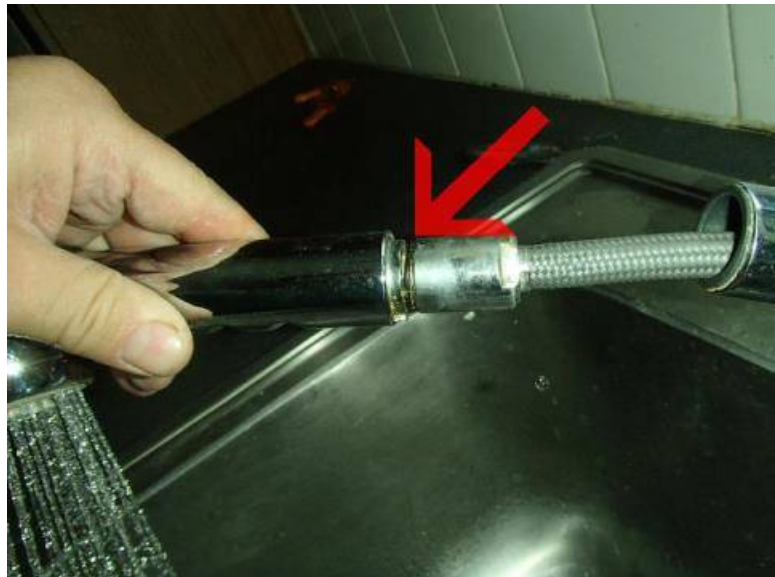
FAUCET:

**Not Acceptable: The kitchen faucet leaks at the base of the line / handle connection.**
