Real Estate Inspection Report

Thursday, March 13, 2014

**6413 Willoughby.
Los Angeles, CA 90038.**

Inspector - Mark Phillips, Lou Fossessa
Confidential and Proprietary

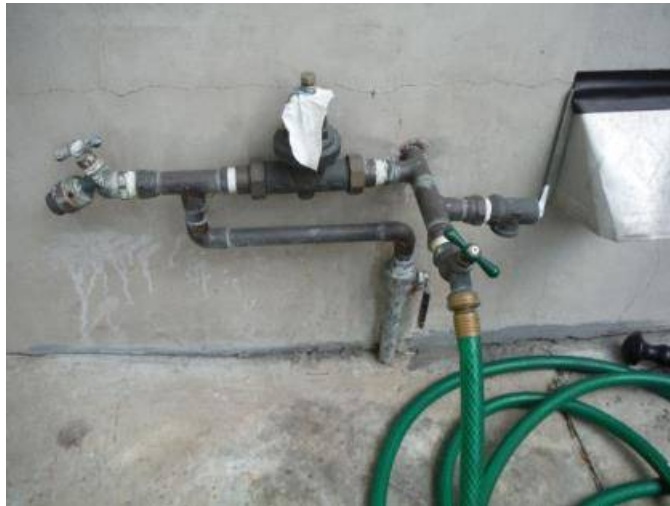
MAIN WATER SHUT OFF LOCATION:

The main water shut off is at the front of each unit.

A pressure regulator was observed on the main water supply line. This device is sealed and its function / condition are not evaluated.

There is a safety pressure relief valve in place as required to reduce the risk of pipes bursting and potential flooding the building. This is not tested or operated, but only noted as being in place. A plumbing contractor could and should test this for correct operation.

Not Acceptable. For 6415 1/2 The pressure is over 80 psi. This is too high, it should be between 40 and 80. The pressure regulator should be adjusted or replaced to bring this down into proper range The pressure tested at 120 PSI.

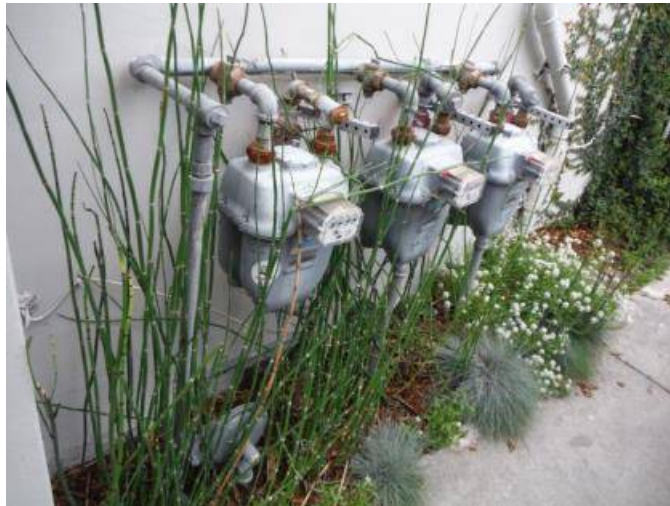
There is an automatic seismic gas shut-off for all the gas meters in the building, There is a separate shut-off for each meter. (A plumber or the gas company could determine if this is the correct size and type, and if it is correctly installed and functioning)

It is advised to have the gas provider inspect the gas system to determine its condition and check all the gas appliances and fixtures. This is usually a free service.

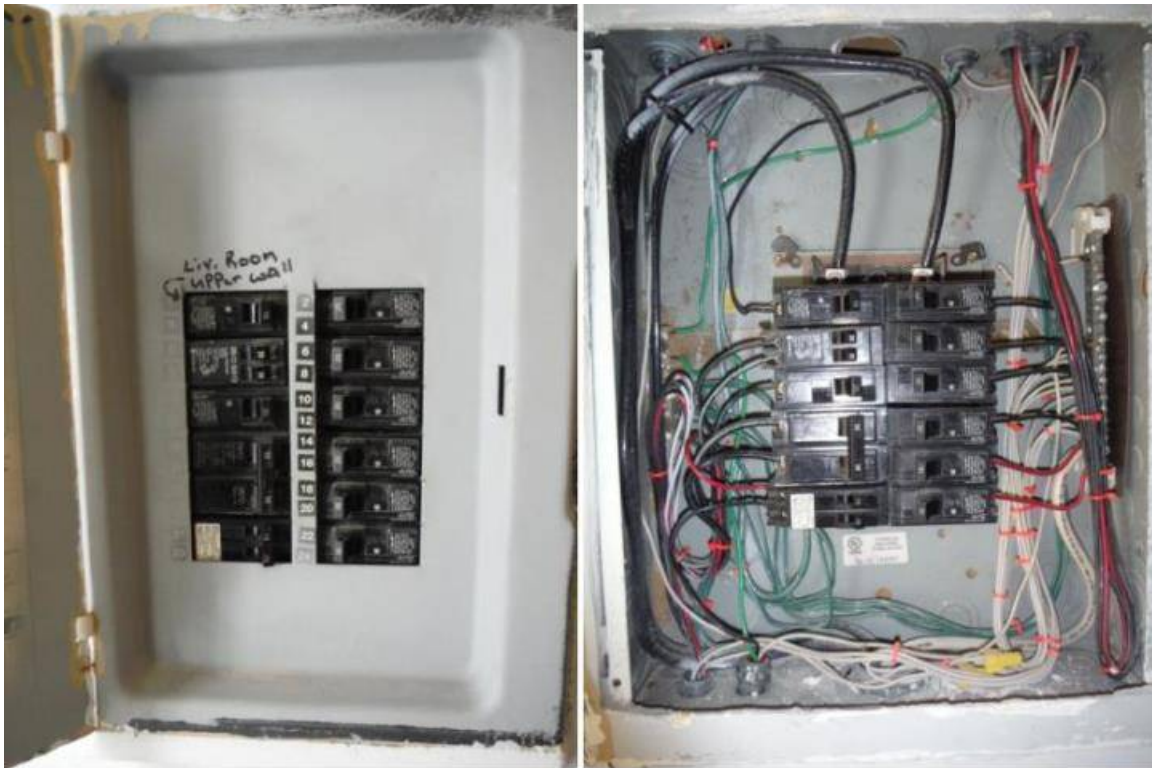
Each unit has the sub panel in the utility room area.

Needs Attention. For the right unit inside the panel there are several openings that need to be sealed with a knock out plug. One of the conduits is not clamped and grounded to the box, this will need repair.

For the left unit, the panel front was blocked so I did not remove the cover. This should be checked by an electrician.

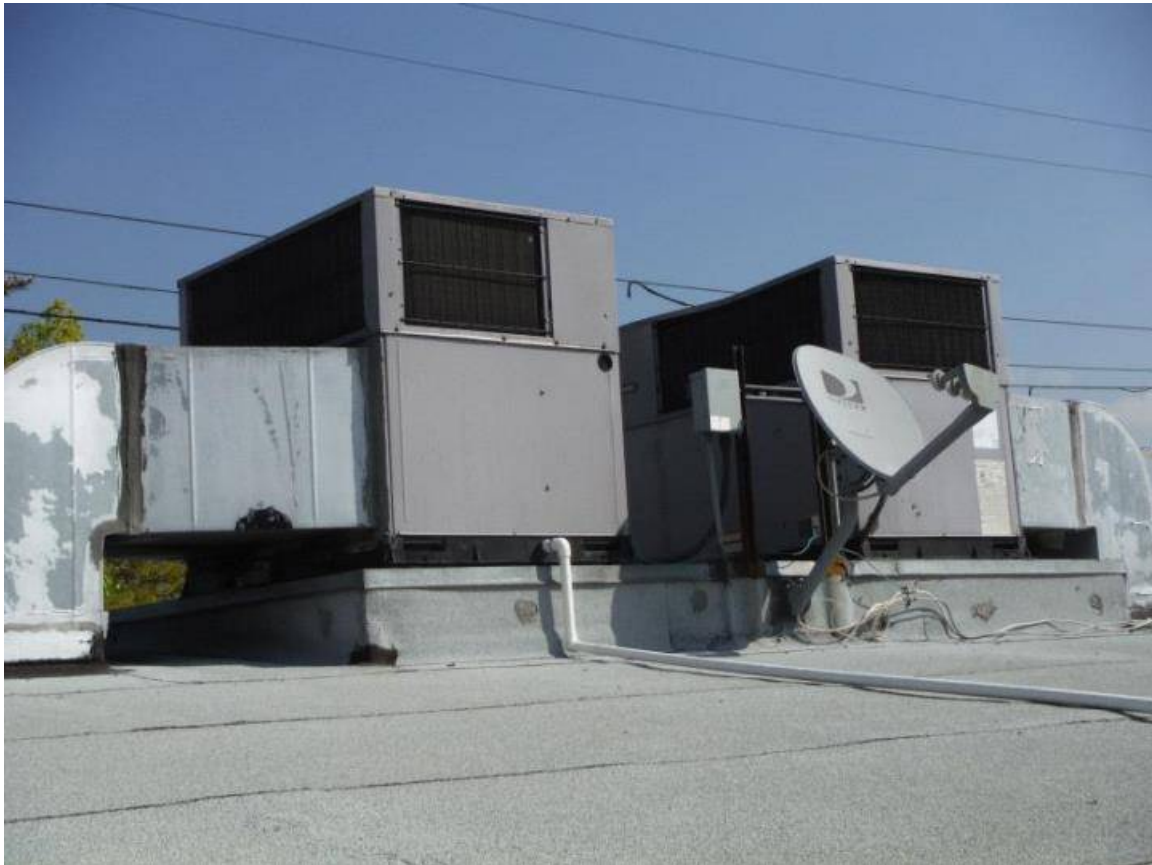
For both units the furnace systems are located on the roof.

The condenser for the air conditioning is located on the roof.

The air conditioning system is a roof package type, this is where the heating and cooling are packaged together in one unit outside the building.

The air conditioning system will need further evaluation to determine its true condition and any repairs or replacement carried out by a qualified air conditioning contractor prior to the expiration of the contingency period so that all the repair costs are known and there are no unwanted expenses. The air conditioning specialist may find addition items that need repair to the system and this is expected and why it is being turned over to them for further investigation.

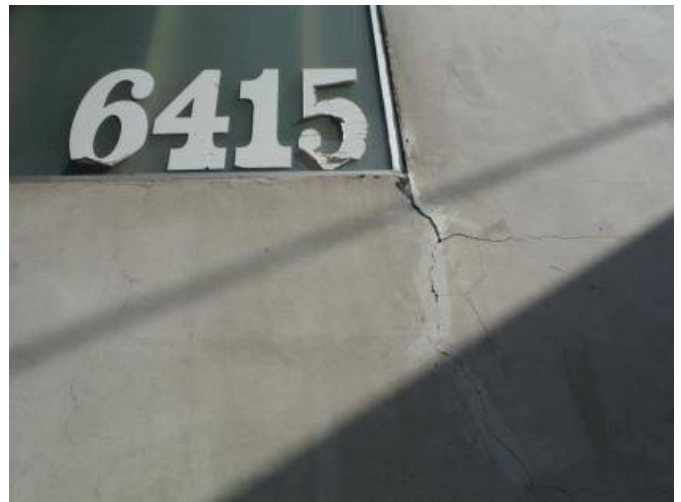
Needs Attention. There are significant cracks in the stucco on the front. These should be repaired and sealed to prevent water entry.

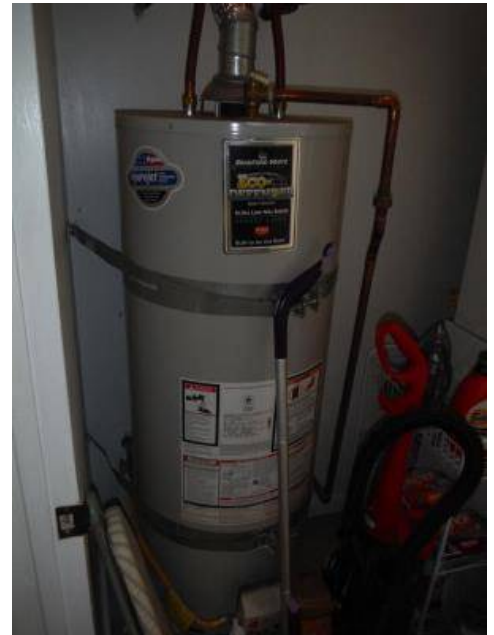
The water heater is located in the utility room.

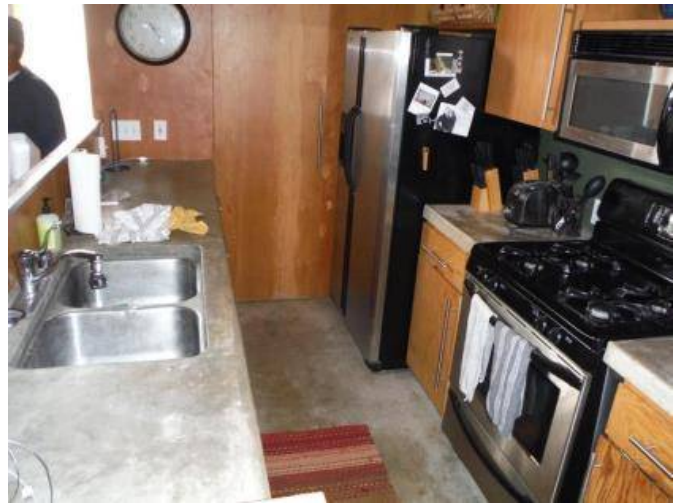
Needs Attention, Cracks and chipping to the concrete counter top.

Needs Attention, There is moisture staining and damage to the shelf area under the kitchen sink Black that may indicate mold.

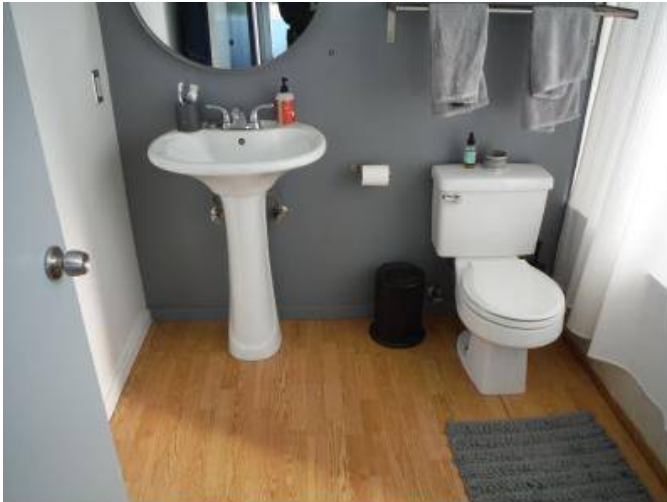
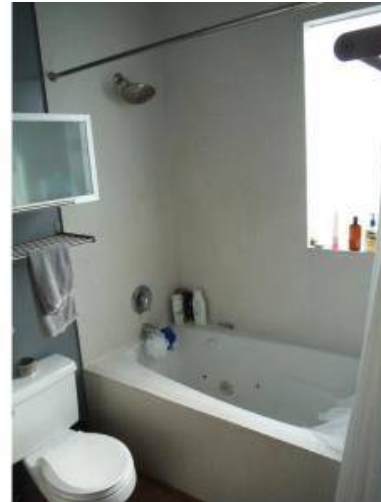
Serviceable. there is an exhaust fan which worked when tested.

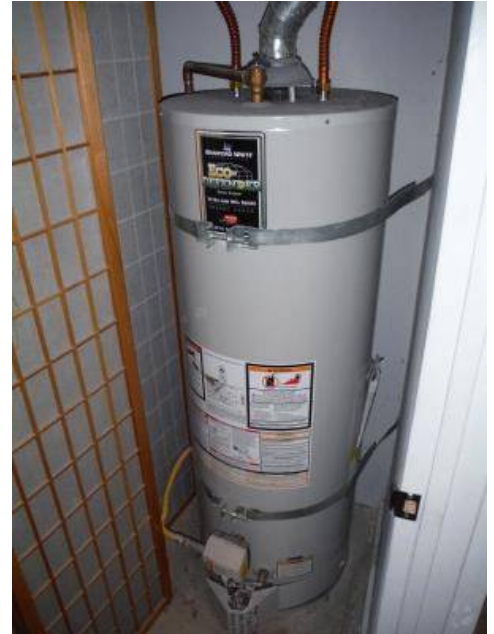
The water heater is located on the exterior of the building in the utility room.

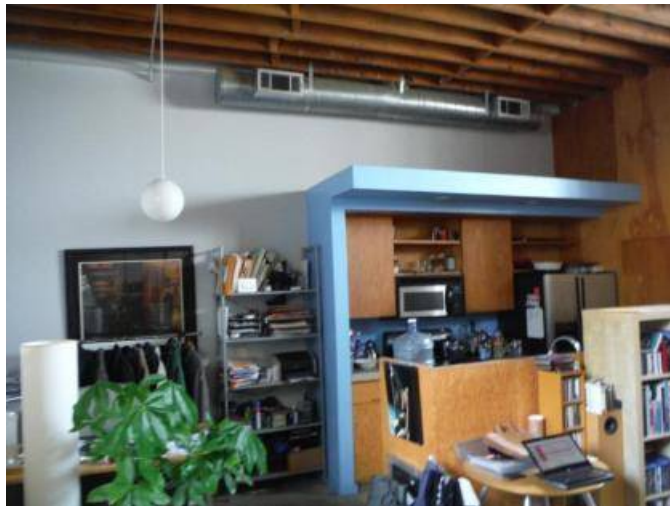
Needs Attention, stained and worn.

Needs Attention, stained and worn concrete.

Needs Attention, The seal between the sink and counter top is deteriorated and should be repaired to prevent water entering the cabinets.

Needs Attention, The water from the dishwasher is coming out of the air gap during the drain cycle. This may be a blocked drain pipe from the dishwasher to the waste line and needs the rubber drain hose replaced.
